# THE FOLLY, SETTLE

## CONDITION SURVEY

## **The Folly, Settle – Condition Survey Notes**

Inspection undertaken on Thursday 3<sup>rd</sup> June 2021 by Sheila Overton. The weather was overcast and dry. The previous inspection was undertaken by Sheila & Mike Overton on 11<sup>th</sup> October 2016.

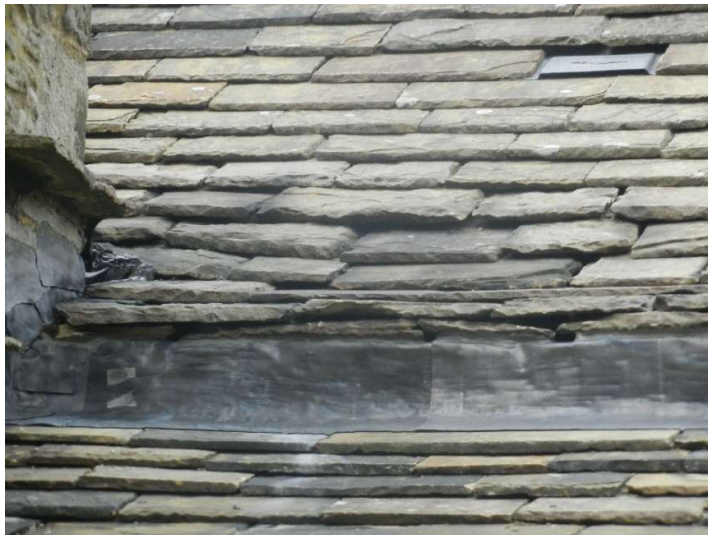
- 1.01 **General Description** - The roofs are slated in Yorkstone slates laid in diminishing courses and have been re-laid within the past 30-50 years on a reinforced roofing felt. Roofing slates run through walls to provide DPC to copings. The roof slates appear to be in good condition. The north garage roof and the two lower lean-to roofs to the rear elevation have been recently re-slatted with new roofing felt.
- 1.02 There is a dip in the west side of the main roof close to the eaves (photo 5). This area has recently been repaired and is currently watertight. However, the dip cannot be made good until the entire roof is re-slatted as the dip is probably due to defects in the rafters which may require replacement. This area of roof will allow ponding which makes it vulnerable to potential water ingress. **C**

photo 5 – dip in roof over east wall in R201

| | | £ |
|---|---|---|
| 1. | Re-slate main roof with new roofing felt and making good dip in west side of main roof close to eaves. (1.05 & 1.02). | 250,000-300,000 |

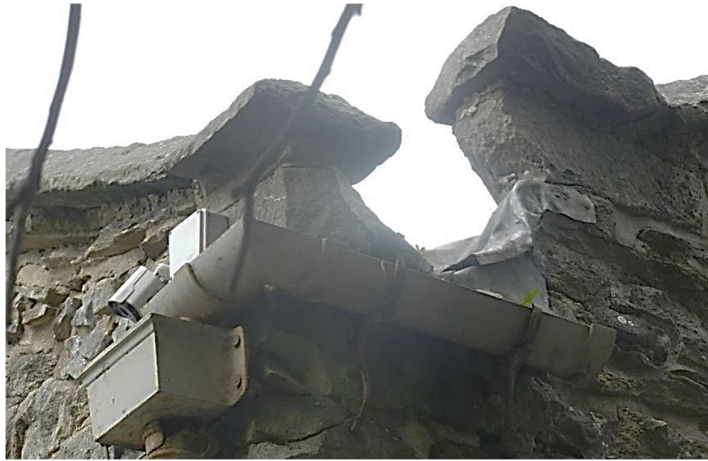
- 1.03 There is internal damp to the wall below the outlet from the valley gutter to the southeast corner of the rear staircase (photo 6). This valley and gutter should be inspected, possibly via a drone survey, to see if there are any defects in this area that need to be attended to. **A**

photo 6 – rainwater outlet from valley gutter over SW corner of rear staircase

| | | £ |
|---|---|---|
| 1. | Valley gutter and outlet to be inspected to ascertain cause of damp in wall below. Possibly by a drone survey. (1.03) | 350 |

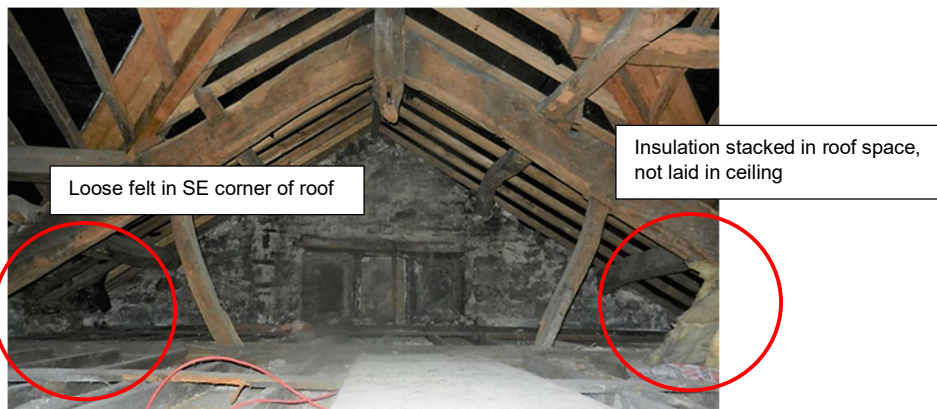
- 1.04 At the time of inspection access was available only to the roof spaces over rooms R202 and R207. The original roof structure has been retained with some new purlins and ridge boards but with new rafters throughout. There is debris between the ceiling joists which is mainly uninsulated. All ceilings should be cleared of debris and insulated when funds are available (photo 7).

photo 7 – roof space over gallery R202

| 1. | All ceilings should be cleared of debris and insulated. Ideally this would be done at same time as re-slating (1.04) |

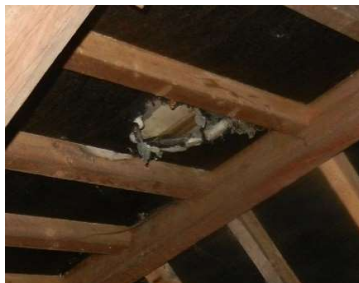
- 1.05 Both these roof spaces had visible holes in the roofing felt (photos 7, 8 & 9). There is loose felt in the southeast corner over room R202 which corresponds with a damp wall below. It is recommended that all the roofing felt is checked by a competent roofer and temporary internal repairs are made to prevent water ingress. These felt repairs are a temporary solution if funds are unavailable for re-slating within next two years. Ideally the main roof should be re-slating within the next two years with a new roofing felt. Due to presence of bats, a bat friendly felt should be used.

photo 8 - roof over R202

| | | £ |
|---|---|---|
| 2. | Temporary patch repairs to be made to underside of roofing felt. (1.05) | 500 |

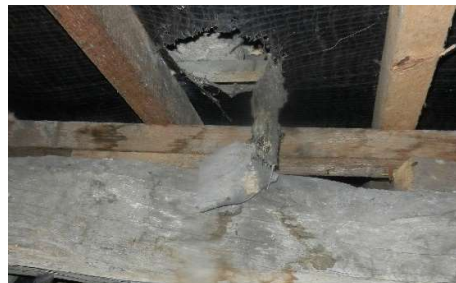
photo 9 – roof over R207

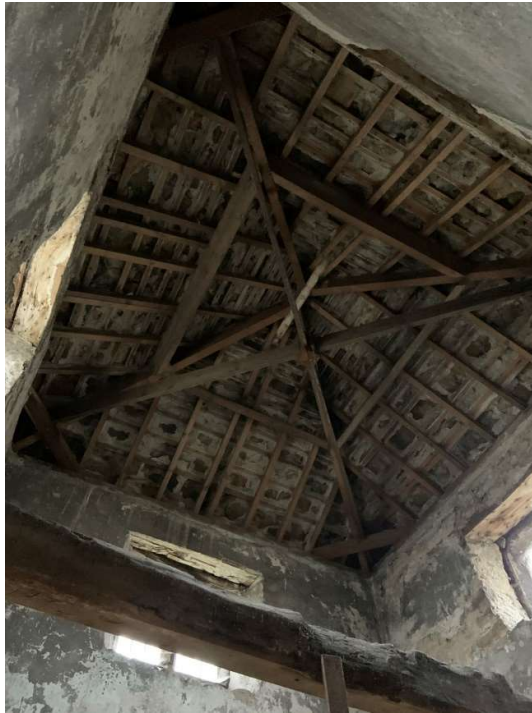
- 1.06 The tower roof had a pyramidal roof structure (photo 10). All structural timbers and rafters are modern and would have been installed within the last 50 years. There is no roofing felt. Close inspection was not possible but appears sound.

photo 10 – tower roof structure

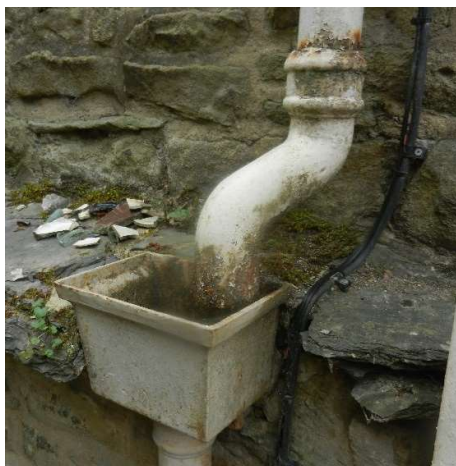
- 2.01 None of the rainwater goods are original. The gutters and downpipes are cast iron. The rainwater goods to the front elevation have been recently overhauled and repainted in grey. The rainwater goods to the rest of the building are painted cream and are all showing signs of corrosion (photos 11 & 12). It is recommended that the rainwater goods to the south, west and north elevations are all de-rusted and re-painted in grey to match the front elevation. Ideally this would be done at same time as re-slating.

photo 11 – corroded rwp & hopper west elevation

| | | £ |
|---|---|---|
| 1. | The rainwater goods to the south, west and north elevations to be de-rusted and re-painted in grey to match the front elevation, ideally done at same time as re-slating & re-pointing. (2.01) | 21,500 |

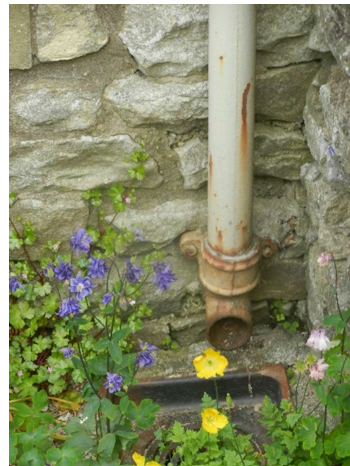
photo 12 – corroded rwp south elevation

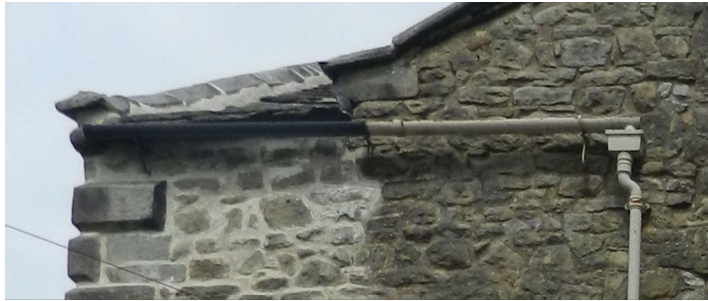
- 2.02 The internal wall in the southeast corner of Room R202 is damp. The gutter to the south elevation should be monitored to see if it overflows in heavy rainfall (photo 13). **M**

photo 13 – gutter to south elevation to be monitored for overflowing

| 1. | Monitor the gutter to the south elevation for overflowing in heavy rainfall. (2.02) |

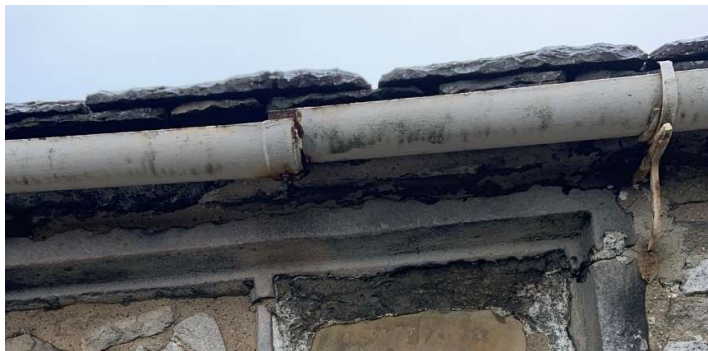
- 2.04 The gutter to the south elevation of the tower has open joint (photo 14). This gutter will need to be made good within a year. **B**

photo 14 – open gutter joint to tower

| | | £ |
|---|---|---|
| 1. | Repair and make good open joint in gutter to south elevation of tower. (2.04) | 250 |

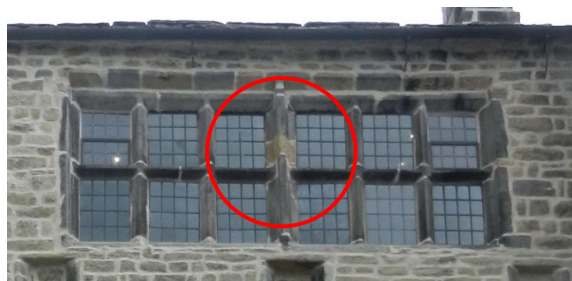
- 3.02 The stone mullion between windows W206 & W207 shows signs of erosion (photo 15). This needs to be monitored and may require specialist repair. **M**

photo 15 – stone erosion to mullion

| 3. | Monitor the condition of the eroded mullion between W206 & W207, if it visibly worsens it may require specialist repair. (3.02) |

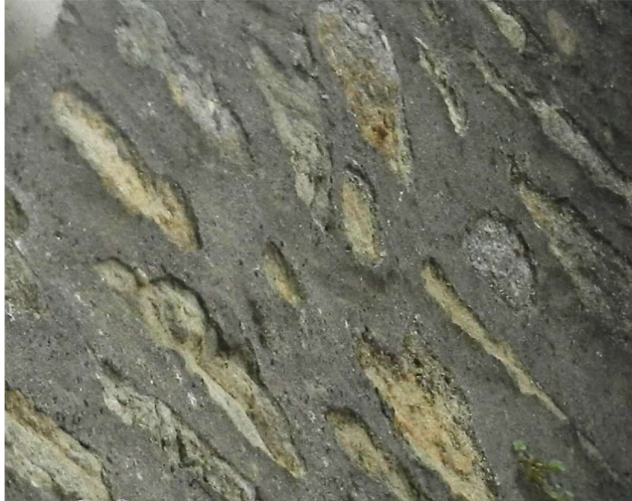
- 3.03 **North Elevation** – The walls are random sandstone which has been covered with a cementitious mortar. There is a substantial central chimney breast and a single storey extension (photo 3). Stone erosion is evident in the exposed stonework (photo 16). The north-eastern corner of this elevation has been repointed in hot lime and the difference is striking.

Photo 16 – stone erosion north elevation

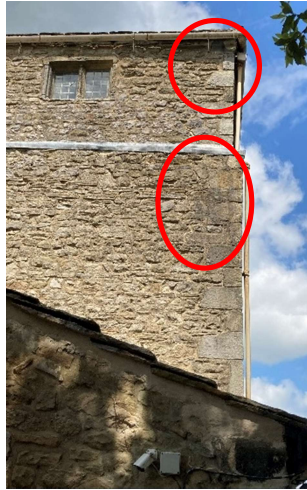
- 3.09 **Tower** – The four stage tower walls are random coursed sandstone with gritstone quoins and cementitious pointing.
- 3.10 There is some cracking to the mortar joints to the quoin stones and windows surrounds, especially in the top stage of the tower (photos 17, 18 & 19). These should be repointed in hot lime mortar. **C**

photo 17 – Location of open joints & crack in mortar in south elevation of tower

| | | £ |
|---|---|---|
| 2. | Completely re-point north, south, east and tower elevations in hot lime mortar. (3.05, 3.08, 3.10, 3.14 & 3.15) | 50,000-75,000 |

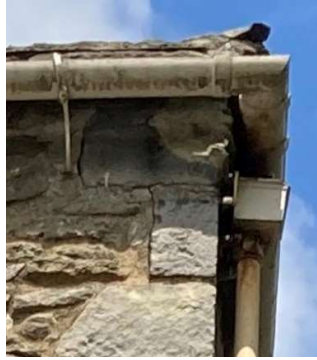
photo 18 – open joints

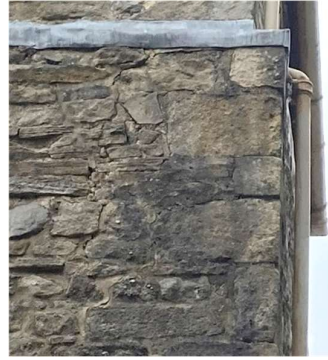
photo 19 – crack in mortar joints

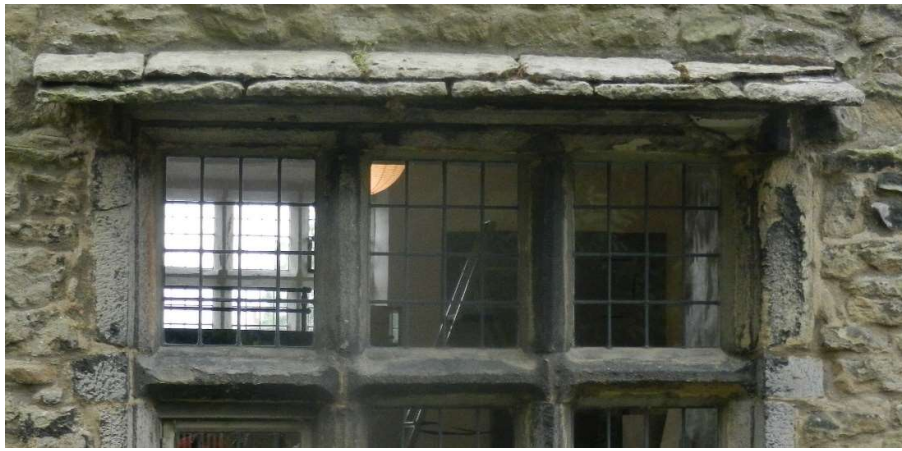
- 3.11 Window W115 has some stone erosion to the north jamb and has a cracked slate to the window head (photo 20). These are not of immediate concern but should be attended to when the elevation is repointed.

photo 20 – Window head W115

| 2. | Replace cracked slate to window hood and repair eroded stone jamb to window W115. (3.11) |

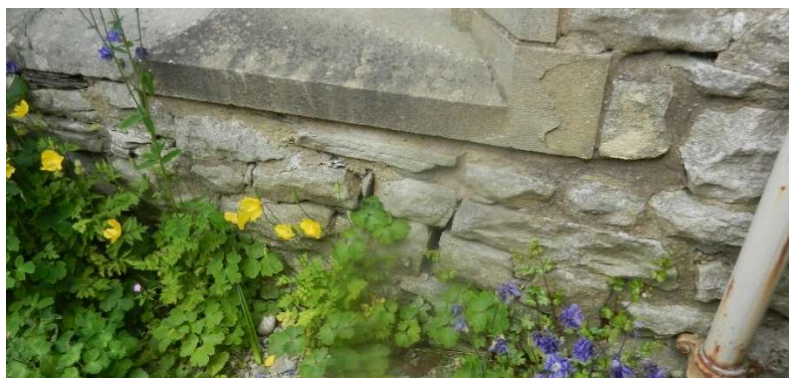
- 3.12 **South Elevation** – There are two south elevations, the gable wall to the main building (photo 21) and the side elevation to the lean-to section housing the kitchen and room R108. The south eastern corner of the gable elevation has been partially repointed in hot lime.
- 3.13 Vegetation growing on the steps in the chimney stack needs to be removed regularly as part of the annual maintenance.
- 3.14 There are open joints under window WG10 which need to be repointed in hot lime mortar (photo 21).

photo 21 –  
open joints  
under WG10

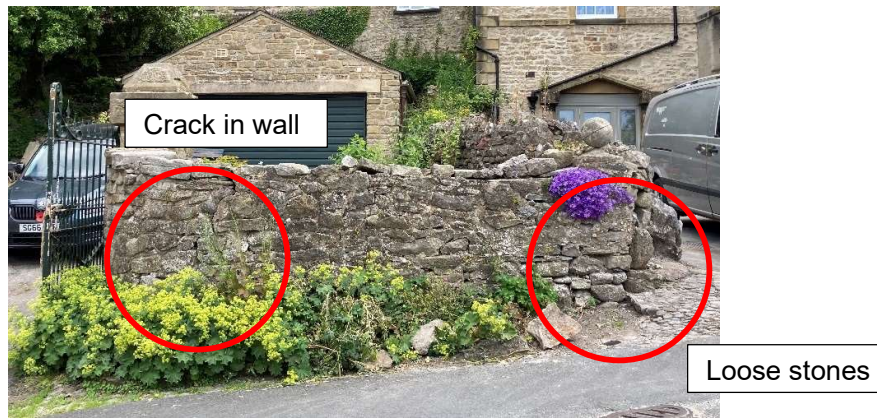
- 5.01 There is an enclosed garden to the rear of the Folly which is well maintained.
- 5.02 Access to the garden is via a pedestrian gate on the north side and a vehicular gate on the south side. There is also a rustic stone staircase from the new catering kitchen. This staircase does not comply with H&S standards and cannot be used by kitchen staff to deliver food to the garden. Consideration should be given to providing a staircase that complies with building regulations and listed building approval.
- 5.03 The south boundary wall is unstable and needs to be partially rebuilt as a matter of urgency for public health and safety (photo 22).

photo 22 – south boundary wall

| | | £ |
|---|---|---|
| 3. | The south boundary wall to be made good and partially re-built as required. (5.03) | 1,500 |

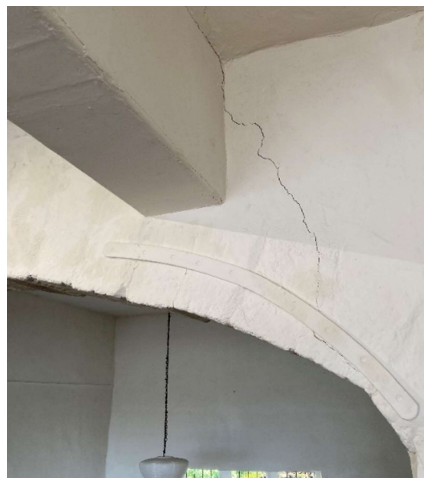
The recent roof repairs to the junction of the tower and gallery roof have caused significant movement to the pre-existing crack in the tower arch resulting in the splitting of one of the voussoirs (photos 23 & 24). The floor has since been closed to the public and the plasterwork to the truss bearing on this arch has been removed. This has revealed that the truss is in a poor condition (photo 25). A structural solution is being developed for the truss and tower arch and initial discussions have already taken place with Historic England. These repairs are urgent and must be undertaken as soon as possible.

Photo 23 – Cracked arch gallery side

| | | £ |
|---|---|---|
| 4. | A structural solution for the truss and beam to be resolved and approved. Repairs to start as soon as possible. (6.01) | 50,000 – 75,000 |

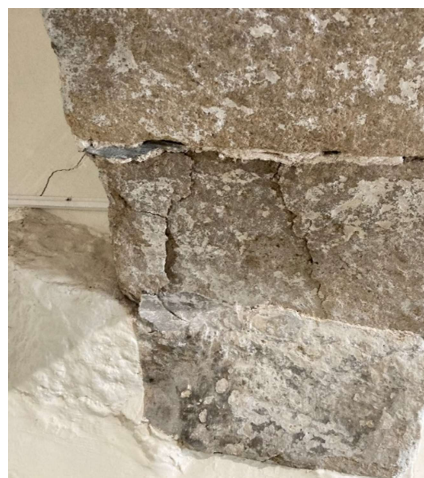
Photo 24 – Underside of arch showing cracked stone

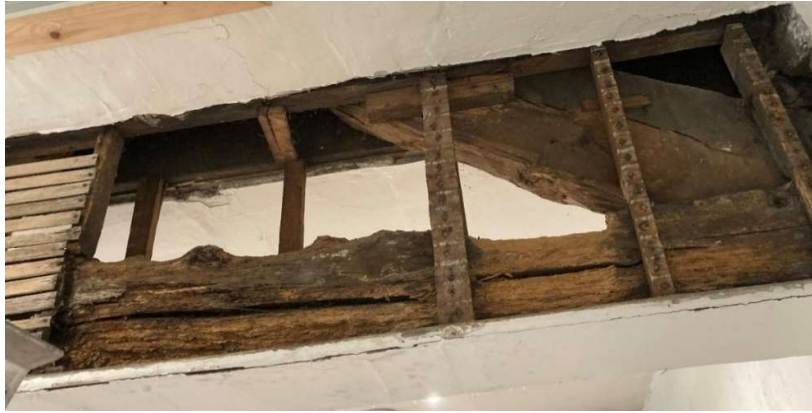
Photo 25 – Truss beam is in poor condition with a large shake and friable timber

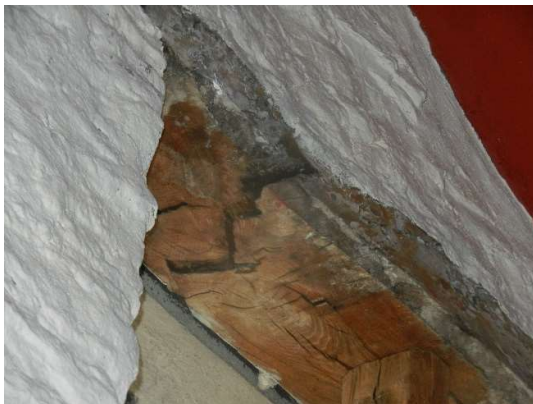
- 6.06 There is a split timber lintel over the high level window to the east wall in R203 (photo 26). This should be checked for stability by a structural engineer. **D**

photo 26 – split imber lintel R203

| | | £ |
|---|---|---|
| 5. | Split timber lintel over the high-level window to the east wall in R203 to be checked for stability by a structural engineer. (6.06) | 500 |

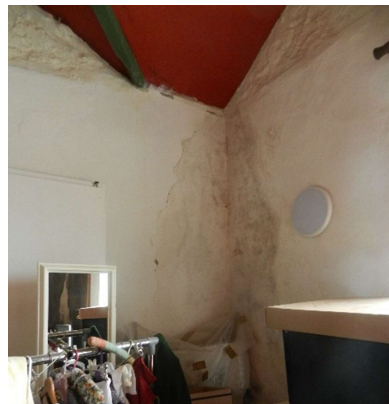
photo 27 – damp SE corner R203

- 6.07 The damp staining in the SE corner of R203 is historic as the roof over has recently been repaired (photo 27). This stain should be monitored for signs of drying out. **M**

| 9. | Monitor the damp stain in the SE corner of storeroom R203, this should start drying out as the roof over has been repaired. (6.07) |

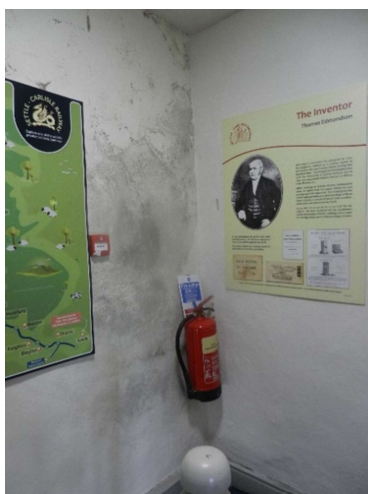
- 6.11 The wall in SE corner of the rear stairwell R209 is badly affected by damp (photo 28). This could be caused by problems with the roof outlet and gutter. See items 1.03 & 2.03 in roof & rainwater goods sections of this report. It could also be exacerbated by the cementitious pointing preventing the wall drying out (3.08).

photo 28 – 2<sup>nd</sup> floor SW corner rear stair

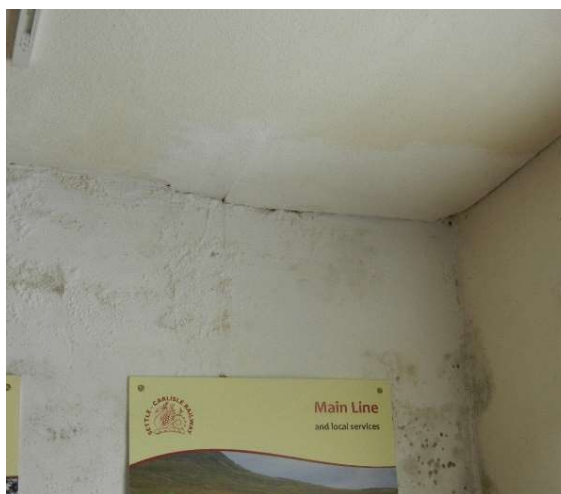
photo 29 – SE corner gallery R202

- 6.12 The SE wall and the ceiling over in small gallery R202 are affected by damp (photo 29). This could be caused by problems in the roof over. Item 1.05 in the roof section noted that there was loose roofing felt over this area. Hopefully when this is attended to there will be an improvement in this wall.

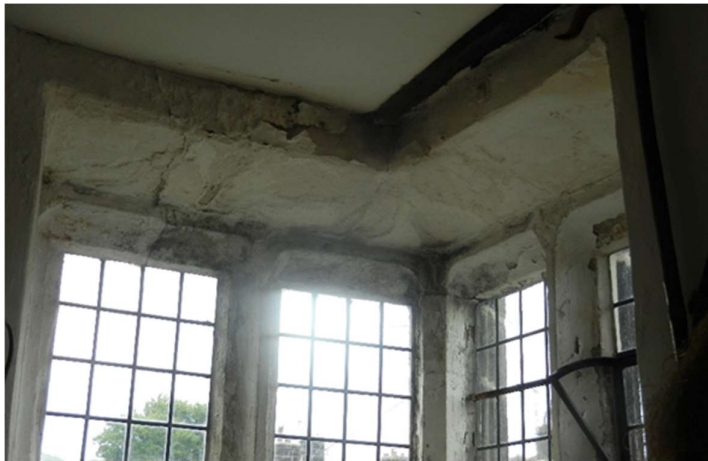
- 6.16 The east wall in main gallery room R101 is streaked with water from the roof leak during the roof repairs. This wall to be redecorated after it has fully dried out. **D**
- 6.17 Window in SE corner of small gallery R102 has damp to the head and to the wall below (photos 30 & 31). The window head may have been affected by water penetration from the roof which has affected the room directly above. The damp wall below this window was probably caused by water penetration through the wall and sill and is hopefully drying out. This section of wall has recently been repointed with hot lime and should be drying out.

photo 30 – window head  
W112/113

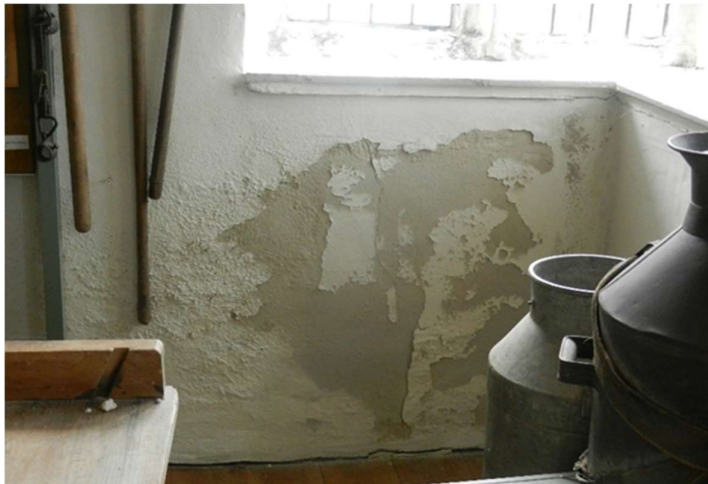
photo 31 – wall below  
W113

| 11. | Monitor the walls in small gallery R102 to see if they are drying out since the wall has been repointed in hot lime. (6.17) |

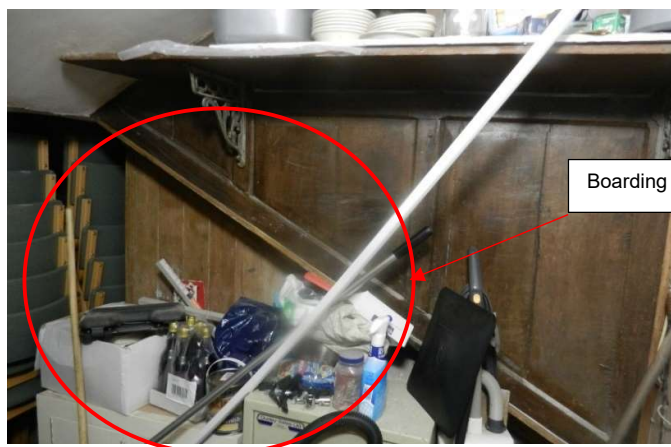
- 6.20 The storeroom under the stairs should have a fire-resistant wall to the staircase **C**  
(photo 32).

photo 32 – under-stair storeroom

| | | £ |
|---|---|---|
| 4. | Construct a fire-resistant wall around the staircase in the understair storeroom. (6.20) | 1,500 |

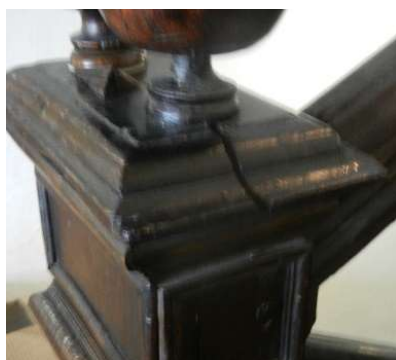
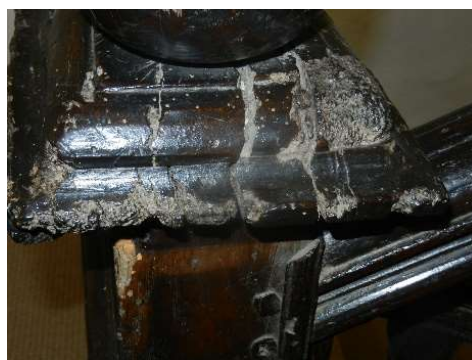
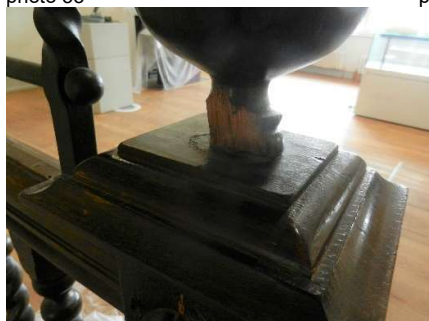
- 6.21 There are some significant cracks on some of the treads on the first flight of stairs, which seem to be stable. If the timber boarding under the stairs is removed (photo 32) it would enable repair work to be taken from the underside of the staircase to attend to these cracks. This boarding does not appear to be original and subject to listed building consent may not need to be reinstated. After a fire-resistant wall is constructed it will no longer be possible to access the underside of the stairs. It is therefore recommended that these treads are attended to before a fire-resistant wall is constructed. **C**
- 6.22 There is some significant damage to the tops of the newel posts (photos 33, 34 & 35). It would be desirable to get these repaired as the staircase is an important internal feature of the building. **E**

| | | £ |
|---|---|---|
| 5. | Repair cracked treads in first flight of stairs before a fire-resistant wall is constructed. (6.21) | 1,500 |
