## Heritage Advice: The Folly

### Site: The Folly, Settle

Application: 2020/22037/LBC

Date: 6.10.20

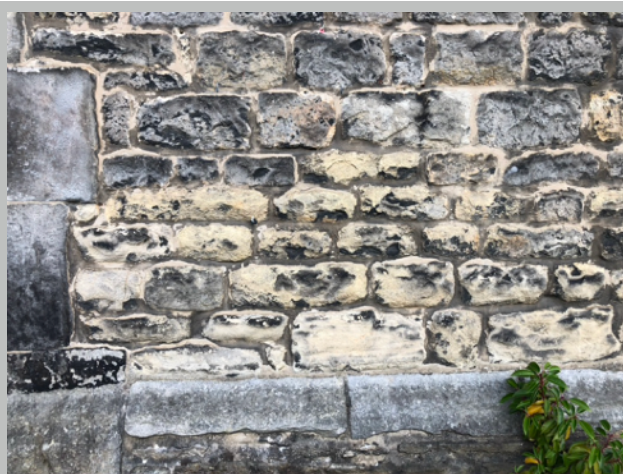
Plate 2. Sample pointing at LH end

The extent of proposed repointing at this stage is limited to the front elevation and the immediate returns. It was agreed that, although a consistent appearance of pointing/mortar on the front is desirable, it should not be pursued at all costs, as there is no necessity to remove any sound suitable or original sound mortar and any removal of mortar can cause damage to the stone. It was agreed that the extent of repointing should be informed by a survey of the type and condition of the existing pointing and that the architects would mark up a survey elevation, highlighting the main areas which are defective and/or inappropriate, although it was accepted that a final decision can only be made on close inspection. Whilst I was inspecting the other parts of the proposal, the architects undertook a rapid survey and came to the conclusion that they consider that the whole of the front elevation would benefit from being repointed. The architects agreed to submit a survey result and a justification statement.

The architects had previously taken samples of mortar and have sent it for analysis and, although they are awaiting the results, their initial inspection of the mortar suggested to them that the original mortar had been a hot lime mix (due to large pieces of pure lime) and that they would therefore be likely to propose to undertake the pointing with a similar mix. They agreed to include

It was agreed that a flush or slightly recessed pointing finish should be used but that a sample panel should be prepared for approval. It was agreed that if the mortar and pointing sample is agreed at an early stage, this would avoid the need for a pre-commencement condition.

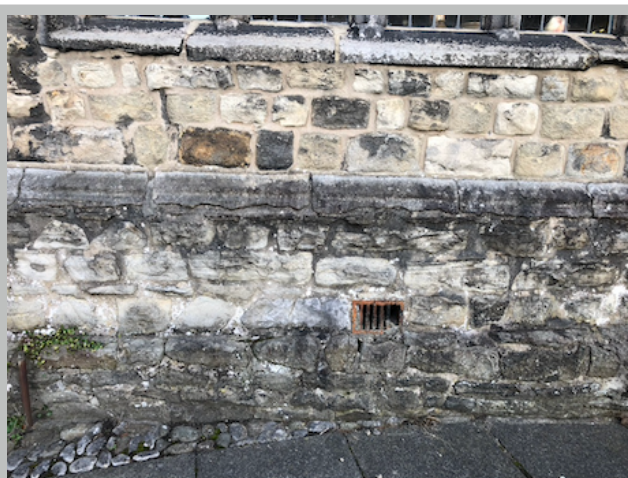
Some of the under-floor air grates are damaged and need to be replaced. I consider that any of the samples shown on Page 5 of the Draft Heritage Statement would be acceptable, although the honeycomb pattern is the most simple and probably most appropriate.

Plate 3. Sample pointing and damaged vent grill

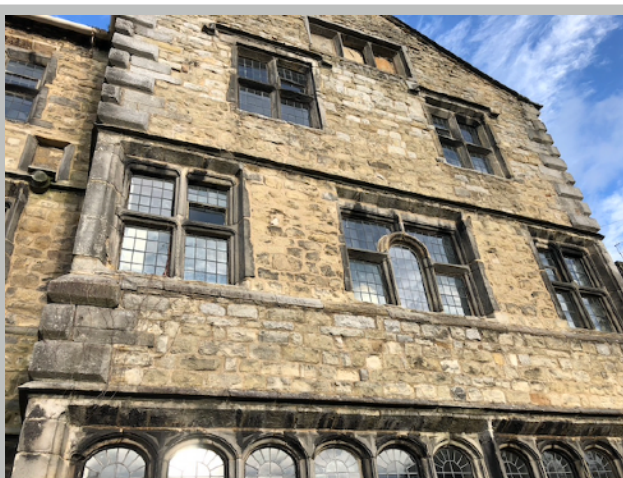
Plate 4. Sample pointing at LH end

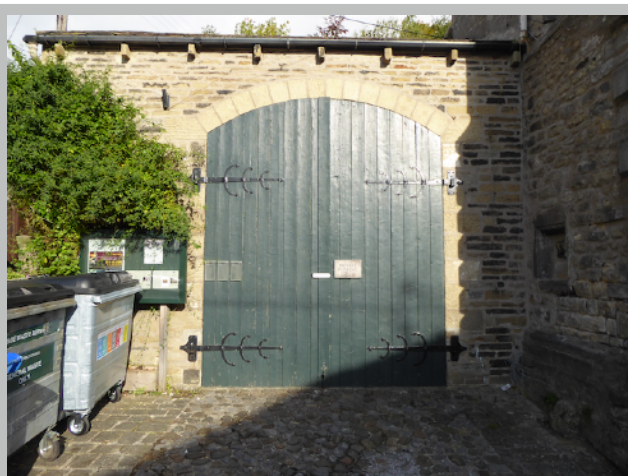
Plate 5. Garage/coach house doors

It makes sense operationally to have the kitchen next to the cafe and I do not consider the proposal would involve any works which would cause harm to the heritage significance of the building. The architect said at the meeting that it is now proposed to omit the pedestrian door in the garage door (and thereby avoid intervention in the decorative iron hinges) and to block up the opening immediately behind and create a larger kitchen. A revised plan will be submitted.

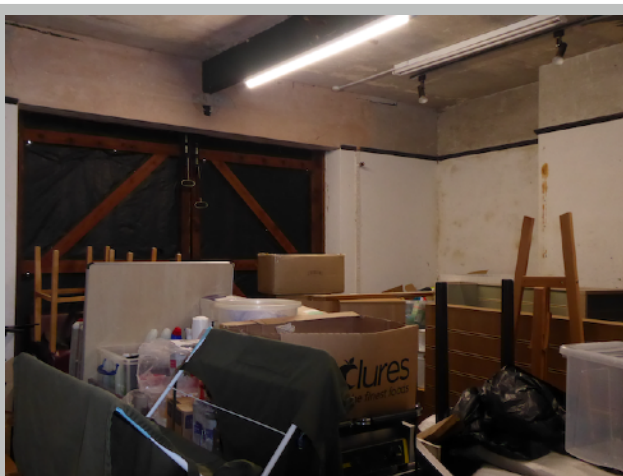
Plate 6. Interior of garage/coach house doors

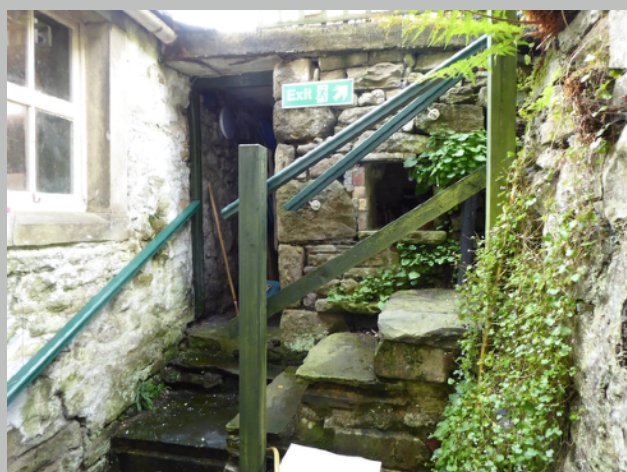
The rear outhouse is created by the rear wall of the garage/coach house, a crucial rear retaining wall, a wall to the public footpath to the W, a wall alongside an external staircase (with an altered window opening) and a flat concrete roof. The proposal cannot realistically involve the removal of the first three walls. The removal of the concrete roof would turn the outhouse into a small open yard and would enhance the heritage significance of the building. However the wall alongside the staircase appears to have quoins of a considerable age and so may have some historic value. It was agreed that further research would be undertaken by the trust to ascertain the date and purpose of the outhouse/yard and further consideration would be given to the removal or enhancement of the wall alongside the staircase, as there is no necessity to remove it.

Plate 7. Outhouse

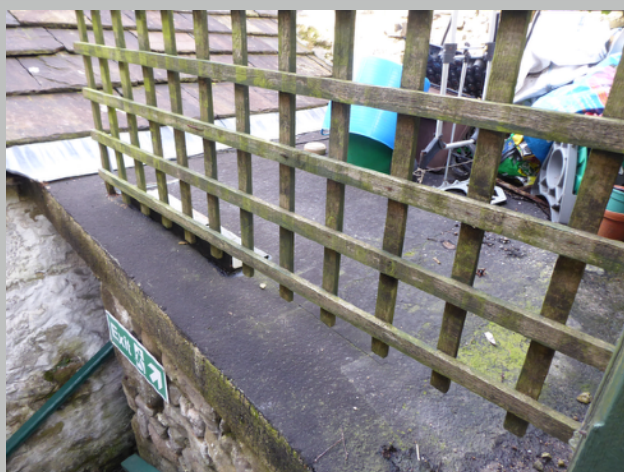
Plate 8. Roof of outhouse

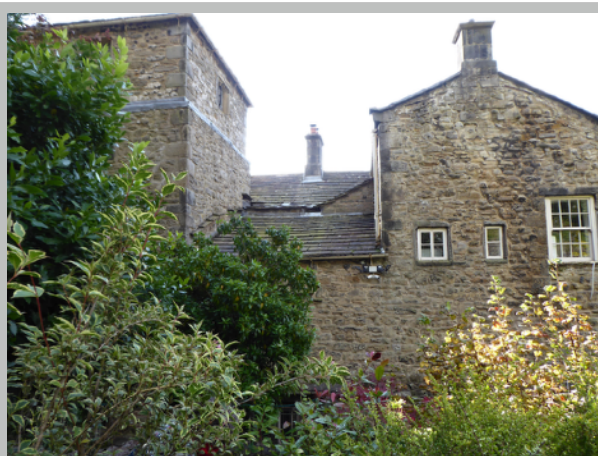
It is clear from an internal and external inspection that the roof is defective and requires repair. Whilst I have every confidence that the works will be undertaken to an appropriate high standard, it is normal in such circumstances to require the submission of a methodology and specification of the works, including the code of lead, either prior to approval or by condition prior to implementation.

Plate 9. Area of roof to be repaired

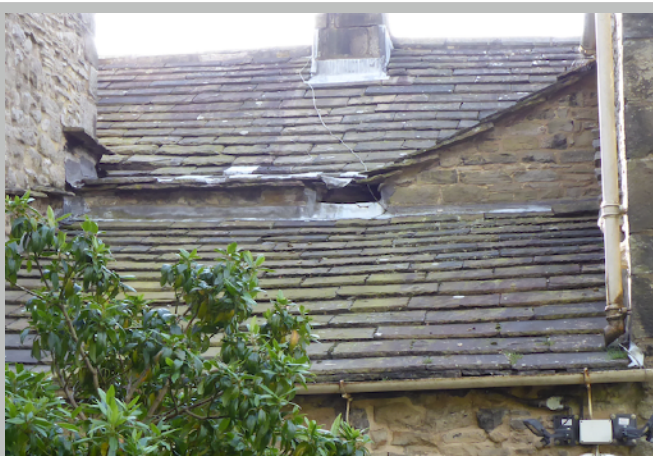
Plate 10. Area of roof to be repaired

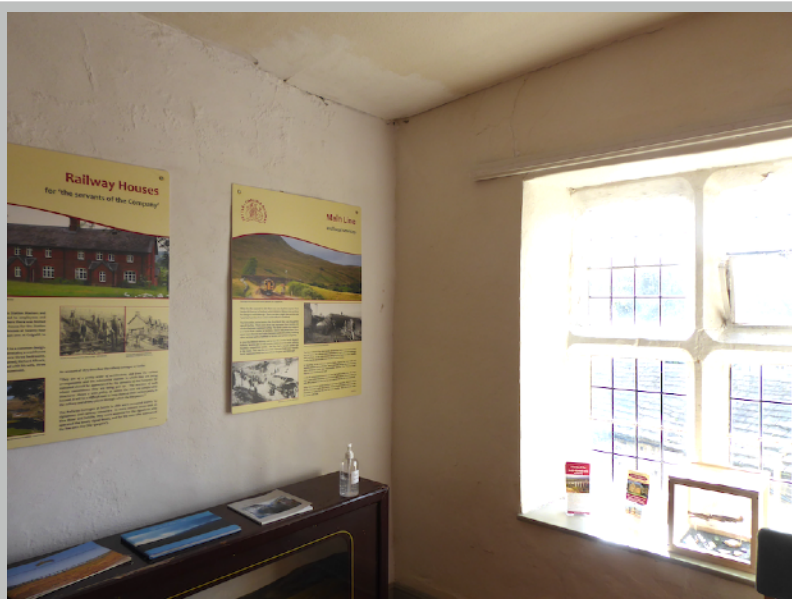
It is clear from an internal inspection that some of the interior plaster work has been damaged by water ingress and it needs to be replaced with a new application of plaster. The proposal is for the use of a traditional haired lime plaster which I consider is appropriate.

Plate 11. Damaged internal plaster

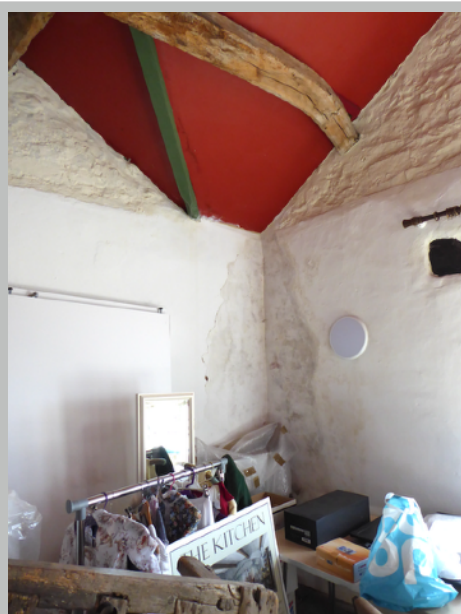
Plate 12. Damaged internal plaster

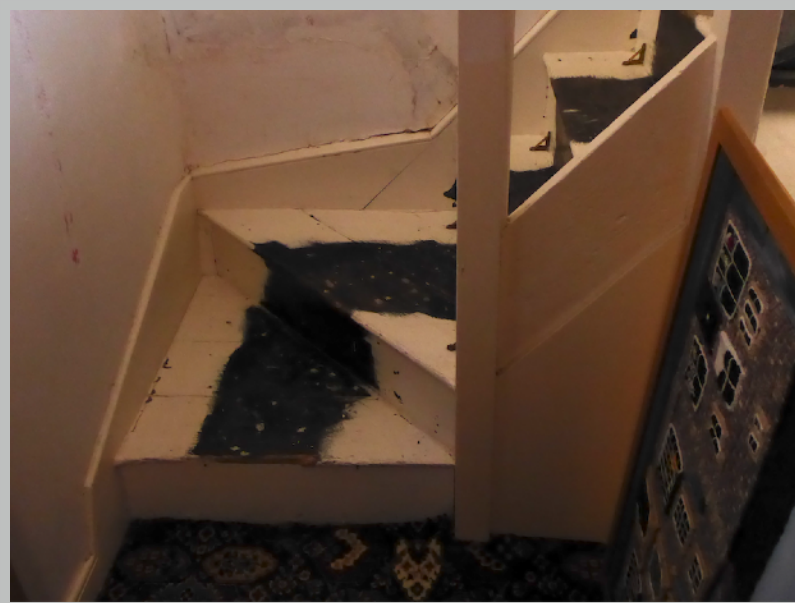
The staircase has been adversely affected by the ingress of water and in any event is a none original staircase of pine treads. The removal of the existing staircase and its replacement with one of similar form and materials will cause no harm to the heritage significance of the building.

Plate 13. Defective staircase

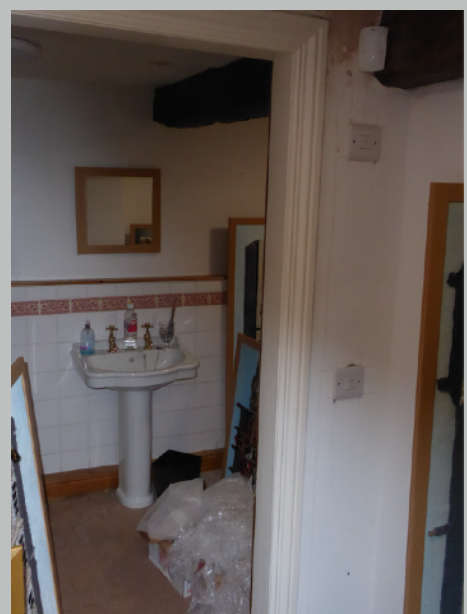
The partition wall and sanitary fittings are relatively recent and their removal will cause no harm to the heritage significance of the building.

Plate 14. Modern partition wall

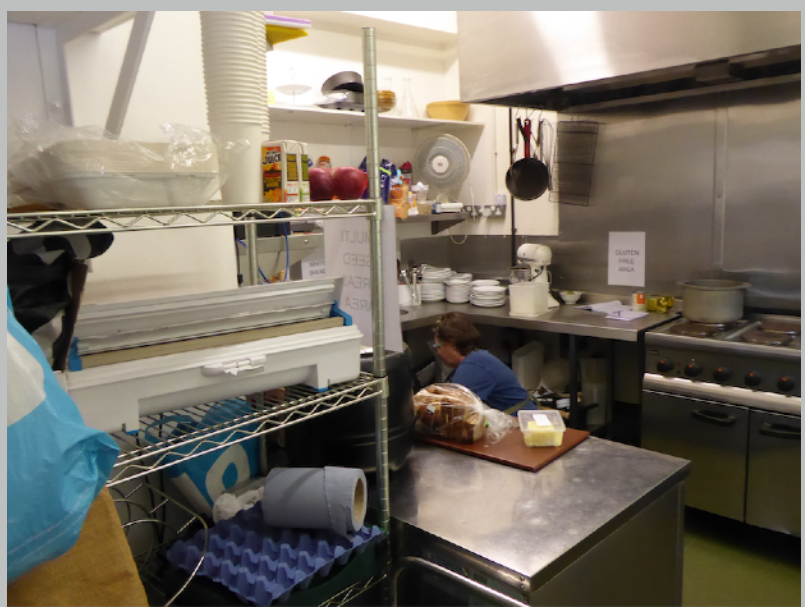
The walls of the boiler room to be removed are modern concrete blocks and the kitchen has no decorative features of any heritage value. The proposed works will therefore cause no harm to the heritage significance of the building.

Plate 16. Kitchen

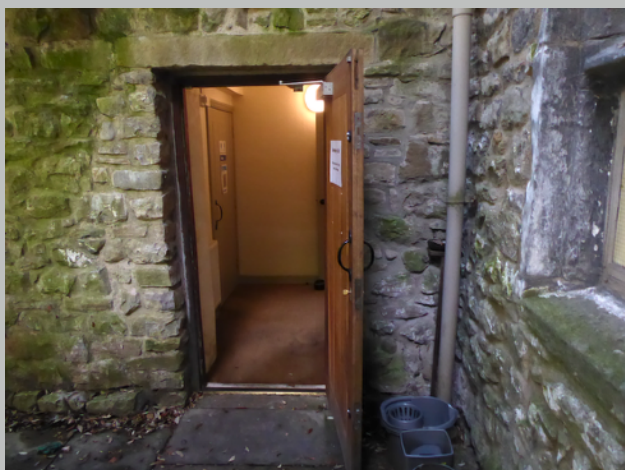
Plate 17. Doorway to be widened

I was initially concerned that these works might involve the loss of some original fabric but, having inspected the proposed route of the lift from GF to 2nd F, I am satisfied that all of the floor and wall fabric which will be disturbed is relatively recent and will therefore cause no harm to the heritage significance of the building. Furthermore, the proposal will enhance the accessibility of the building to a wider group and will enable the removal of the metal bridge, which, although in a relatively discrete location, detracts from the appearance and significance of the building. I was also assured that the lift will not require excavation of a pit or the creation of an over-run in the roof. The drawings suggest that the rear GF needs to be widened but, although this will involve some intervention in structural masonry, the doorway has clearly been altered or created relatively recently and this is an acceptable level of intervention, provided it is made good in matching stone and mortar. The precise details of the extent of intervention required internally should ideally be provided. Overall the proposed works will enhance the operation and significance of the building.

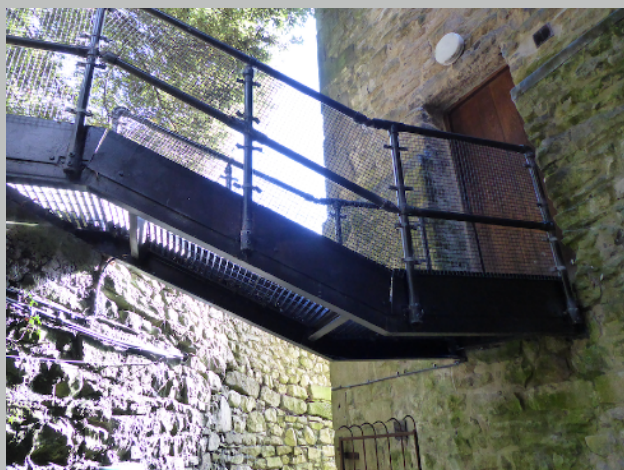
Plate 18. Bridge to be removed

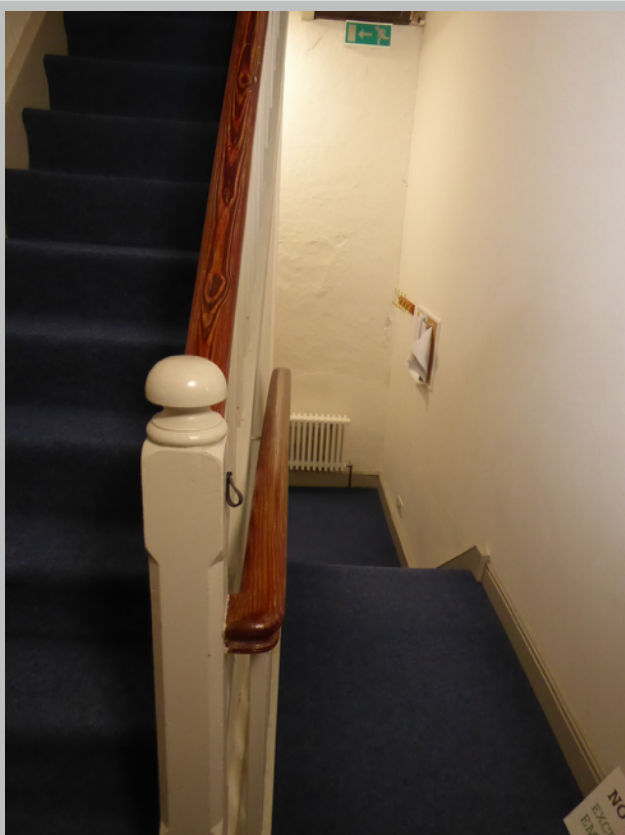
Plate 19. Staircase to be replaced

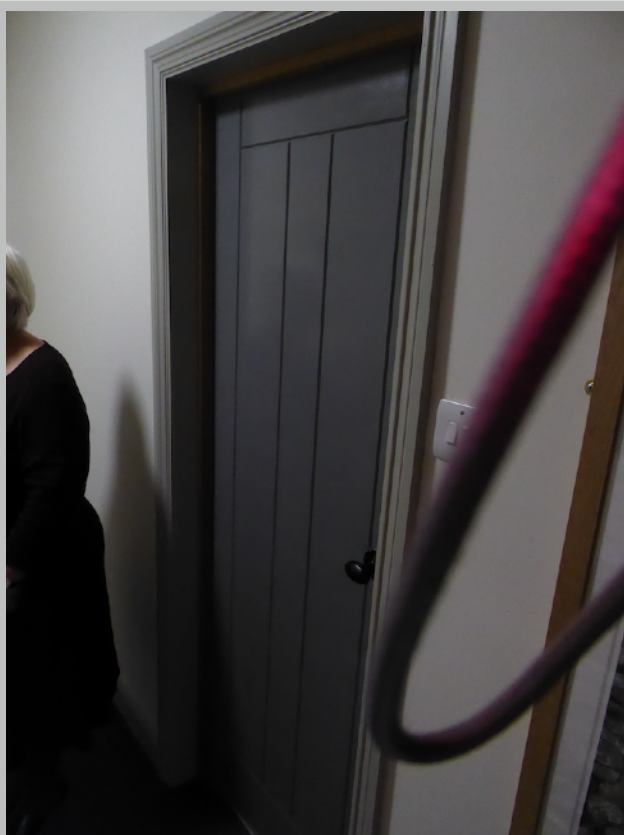
Plate 20. Modern door to be replaced
