# **The Folly, Settle, North Yorkshire**

## **Statement of Heritage Significance & Scope for Change**

The Folly, Victoria Street, Settle, BD24 9EY

Statement of Heritage Significance & Scope for Change

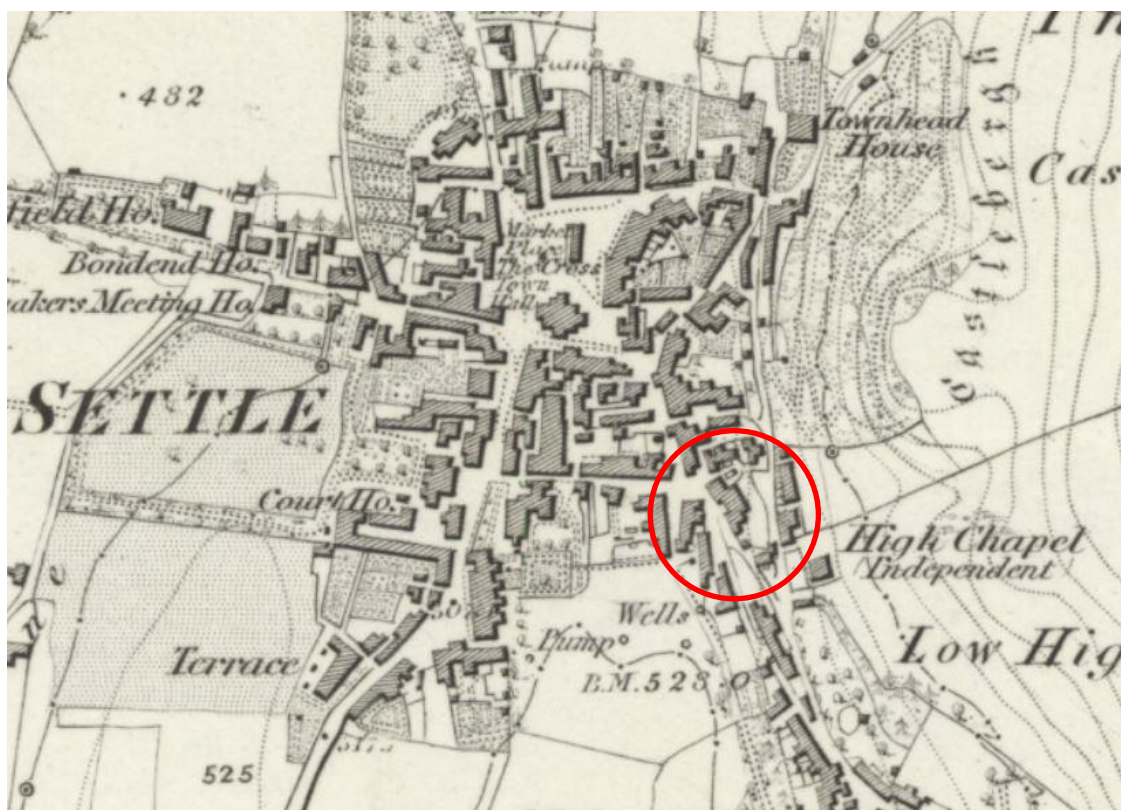
*Fig.2: The Folly on the 1st edition OS map, surveyed 1847, 1: 10560*

The name of the building has changed over time. By the late 18<sup>th</sup> century, the building was known as Settle Hall and was advertised to let, 'for one or two separate families... and very suitable for a manufactory'.<sup>18</sup> By 1816, it was still known as Settle Hall and in use as a farmhouse occupied by Charles Duckett who farmed over 464 acres.<sup>19</sup> By the mid 19<sup>th</sup> century, the building was known as The Folly; the reason for this change is not recorded, but may be a reference to the lavish style of the building which by then was in multiple occupation, rather than to errors of judgement by Preston or Dawson. The building is clearly marked on the 1842 tithe map and the 1847 OS map (Fig.2), with its distinctive footprint. In

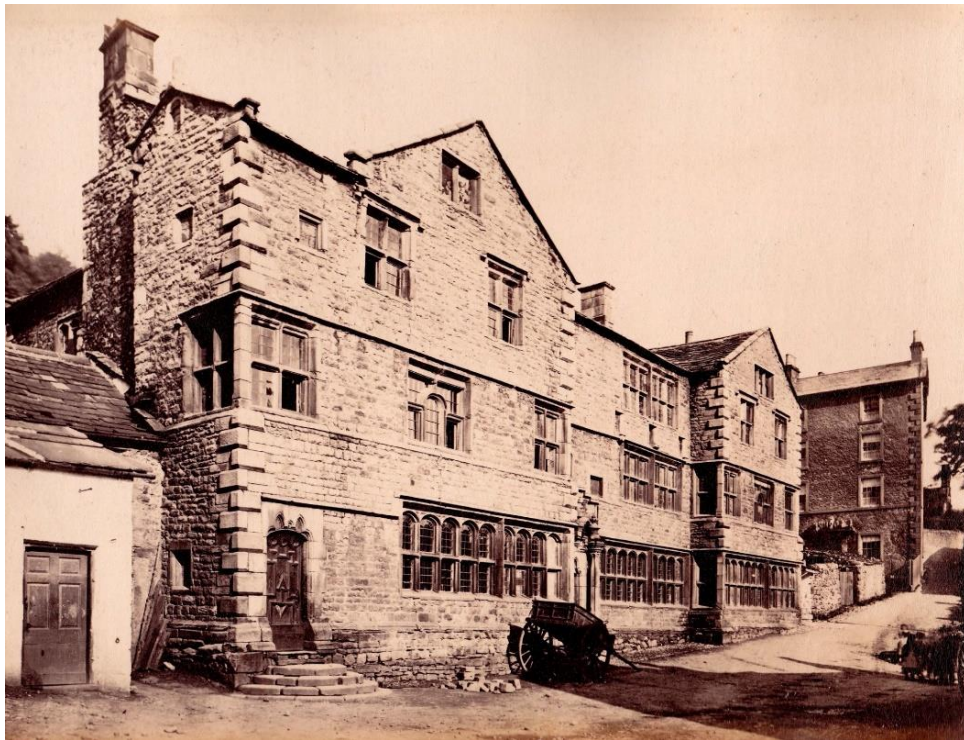
*Fig.4: The Folly in 1887 (NCBPT)*

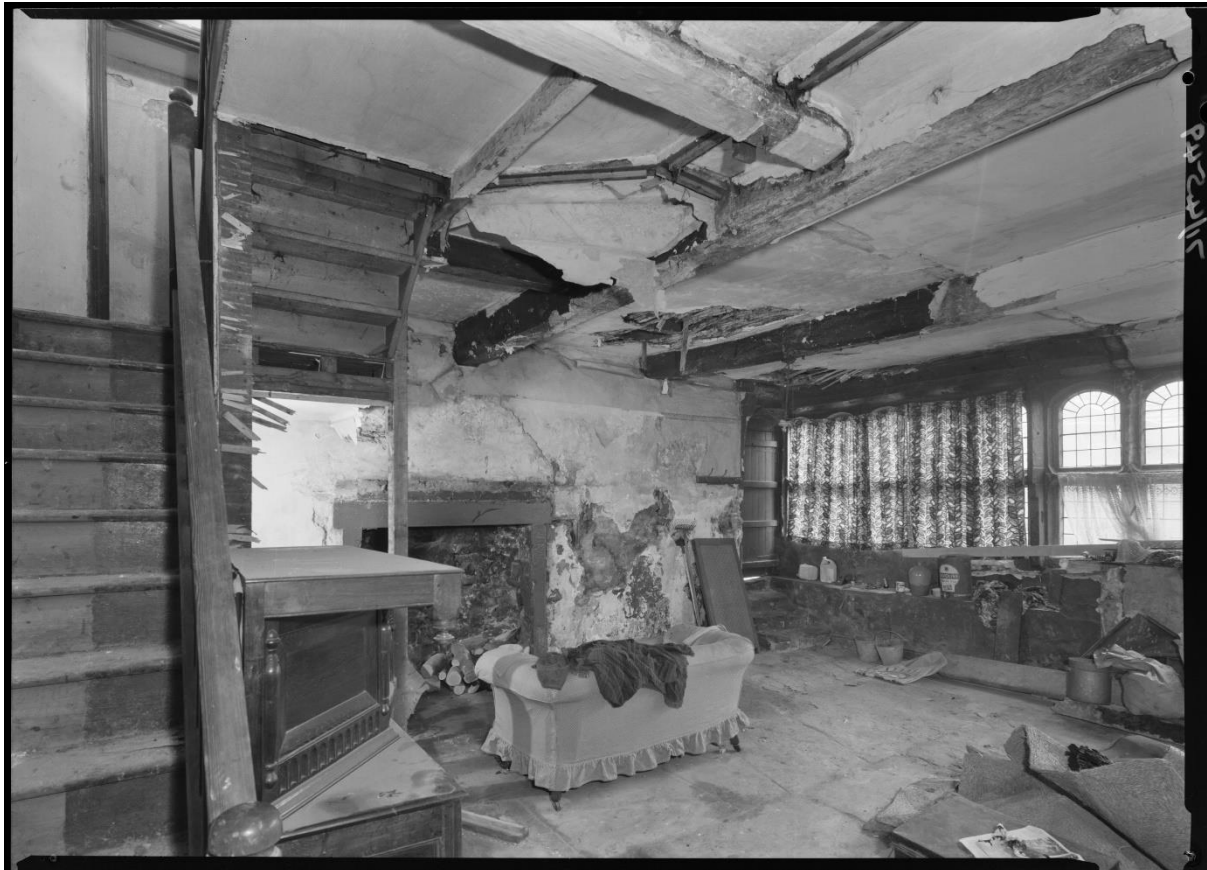
*Fig.6: the parlour from the north in 1971 © Crown Copyright. Historic England Archive - image ref: bb71\_04549*

accessed by a bridge from the rear garden. Parts of the Folly including the south parlour became dilapidated, as recorded by the RCHME in 1971 (Fig.6).<sup>29</sup> At that time the north part of the ground floor and the single-storey north range was in use as a branch of Barclays Bank.

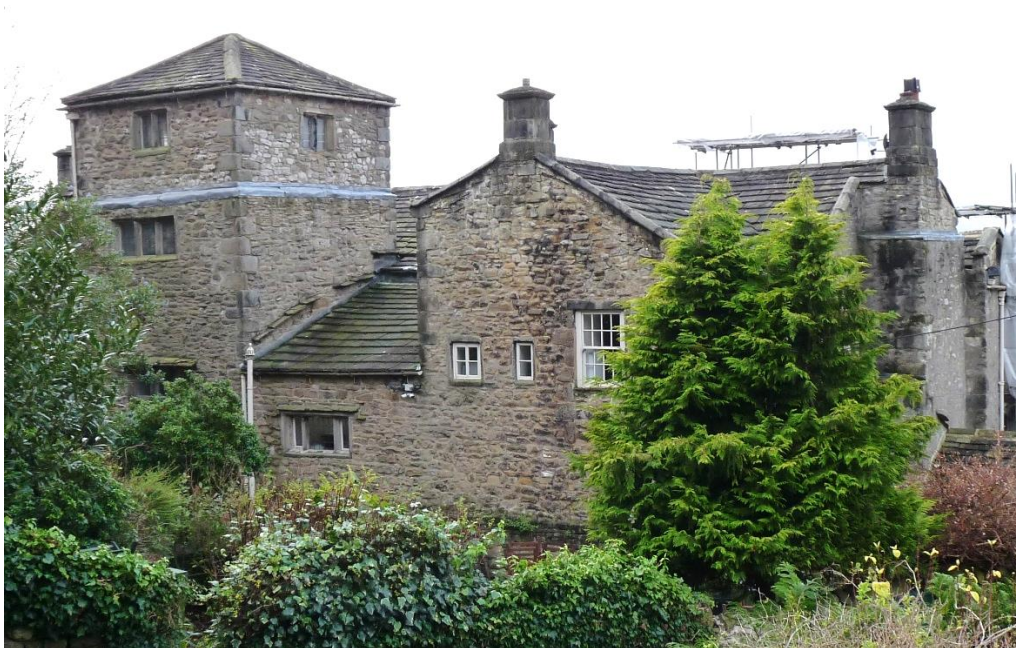
The principal staircase opens from the rear side of the hall contained within a square tower at the back of the building. The Folly is unusual for the height of the stair tower that extends above the roof in the form of a prospect tower. The original means of access into the upper tower room has not been identified and further detailed investigation would be needed to resolve the phasing and planning of the tower. There are three secondary staircases; two of similar design and late 19<sup>th</sup> century date in the north and south wings and one in the north-east outrigger, also an insertion, probably a replacement for a stone service staircase (from G12 to F10).

*Fig.7: Rear of the tower, north-east outrigger and north wing from the north-east*

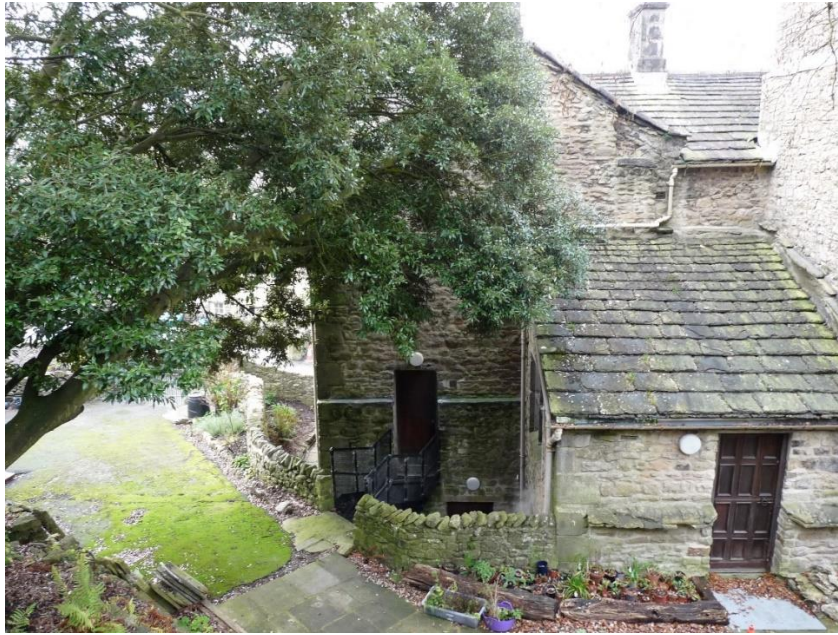
*Fig.8: south-east outrigger and east gable of south wing, from the east*

The south-east outrigger contains an unheated service room on the ground floor and a heated chamber above; It has been previously suggested that the first floor of this outrigger is a later addition,<sup>38</sup> but its window is similar to other mullioned and chamfered windows on the building, typical of the late 17<sup>th</sup> century.

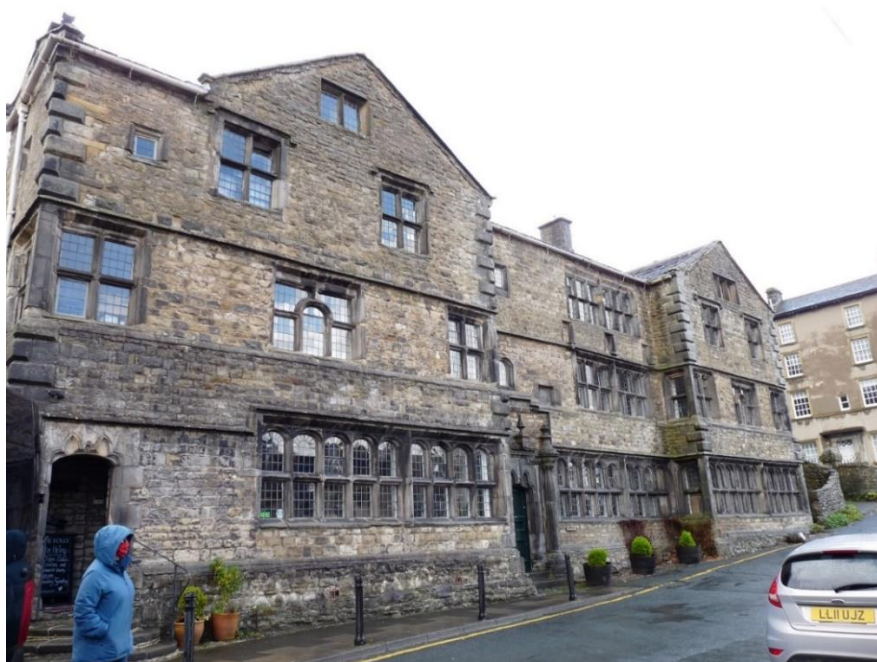
The west front is one of the most striking examples of a 'show front' on a 17<sup>th</sup> century lower gentry house in the north of England. Its showy style could be compared with the lavish timber-framed town houses of similar date in Chester, York or Shrewsbury or the brick East Gate House in Rochester (late 16<sup>th</sup> century). Giles and Pearson discuss the trend for 17<sup>th</sup> century gentry to express their status through the building of new houses, particularly those with lavishly decorated frontages; Giles associates 'show' frontages with houses built by men who were newly arrived in the gentry class.<sup>39</sup> Pearson also notes that gentry houses are differentiated from the houses of yeomen by having three floors, not two, that town houses may be taller than the equivalent rural house and that tall gabled frontages were partly built for status; sometimes upper windows lit unused spaces.<sup>40</sup> There has been previous debate about whether the upper floor of The Folly is an addition, but the current study found no firm evidence for this.<sup>41</sup> The context of other gentry houses and the overall form and character of the building suggests it was built in one overall phase, and that the current appearance of the frontage is as intended by Preston, to express his status.

*Fig.9: west elevation, 2020*

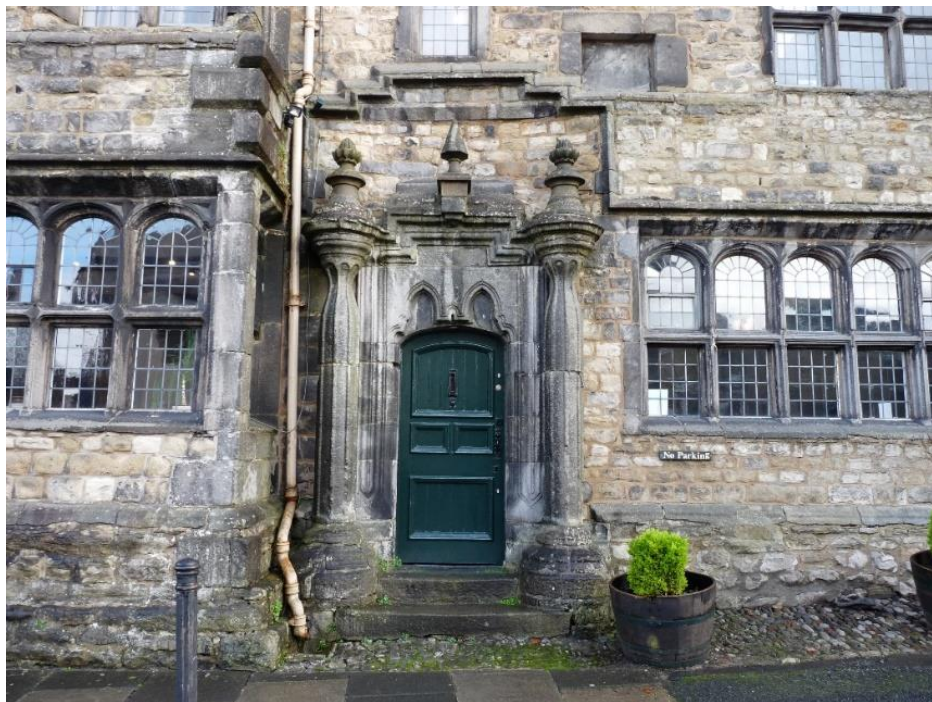
The masonry is of coursed local stone, varying from ashlar for quoins and front door surrounds, dressed squarish stones for regular courses on the front to random rubblestone for the rear. The stone is mainly sandstone with some limestone, particularly to the tower's north elevation. Variations in the quality of the masonry to the front elevation include less well-laid stone to the attic gables. The front elevation is articulated horizontally by a moulded plinth and string courses, which form continuous hoodmoulds to the lower floor windows; the lower storey walls are thicker than those above, with a chamfered weathering course marking the change in wall thickness.

*Fig.10: the hall doorway*

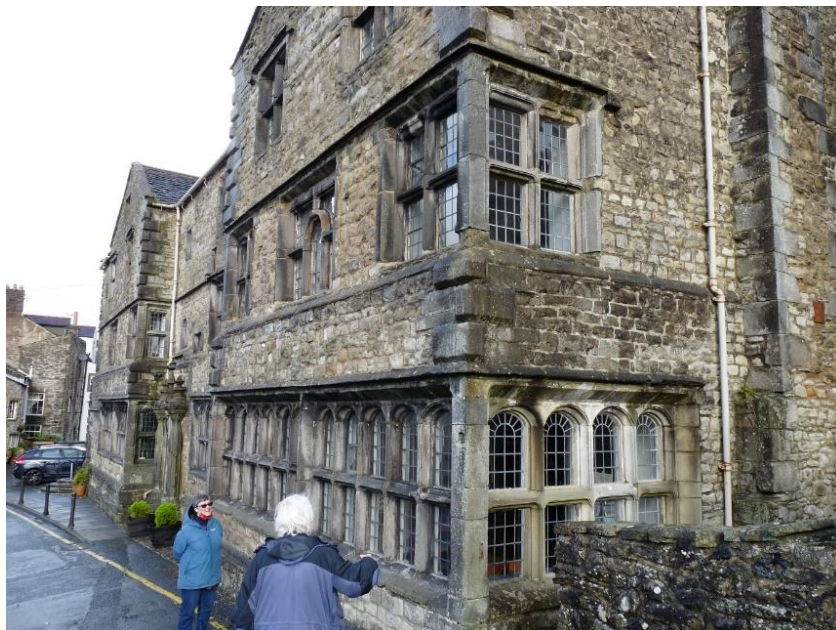
The projecting wings have corner windows, which form a continuous run of fenestration across the elevation, a feature of some larger gentry houses such as Astley Hall, Chorley, but also recorded on porches and bay windows at smaller gentry houses in the Pennines such as The Lodge, Reedley Hollows and Worsthorne Hall, Lancashire, both demolished.<sup>46</sup> All the leaded window glazing has been renewed as part of 20<sup>th</sup> century restoration projects, apart from some attic and tower windows which are blocked with stone. Some windows have steel hoppers, for ventilation.

*Fig.11: corner windows to the south wing*

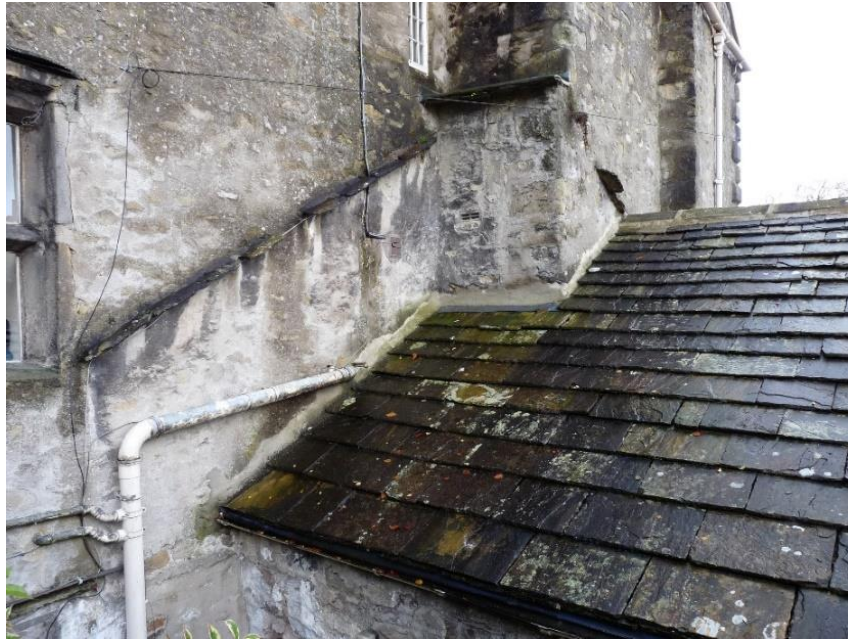
stone slab tabling to throw off water. The same stone slabs have been laid in the wall as a continuous course above the ground floor rear windows, except to the rear of the north wing; they mark (and protect) the top of the thicker lower wall. Stone tabling is also used to protect the junction of walls and roofs, and in some cases shows that the existing roof line is not the original; in particular the single-storey north outbuilding replaces an earlier building on this site, which had steeper roof with a ridge further east (Fig.11). The tabling above the outrigger north of the tower is higher than the present roof slates, perhaps indicating this roof has been lowered or was perhaps a deeper roof, laid with thatch for example.

*Fig.12: tabling to an earlier and higher roofline on the north elevation*

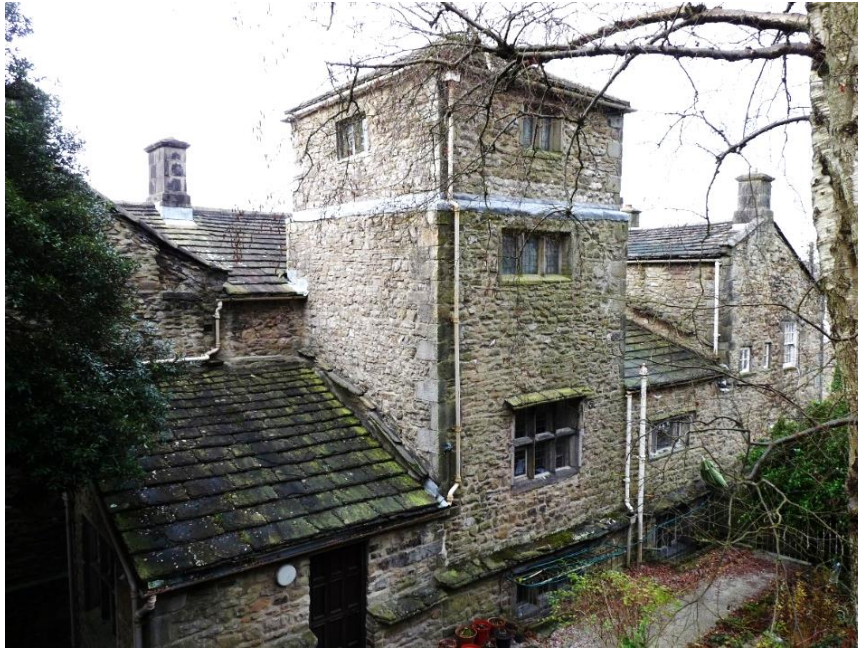
*Fig.13: rear elevation with stair tower and plainer windows, from the south-east*

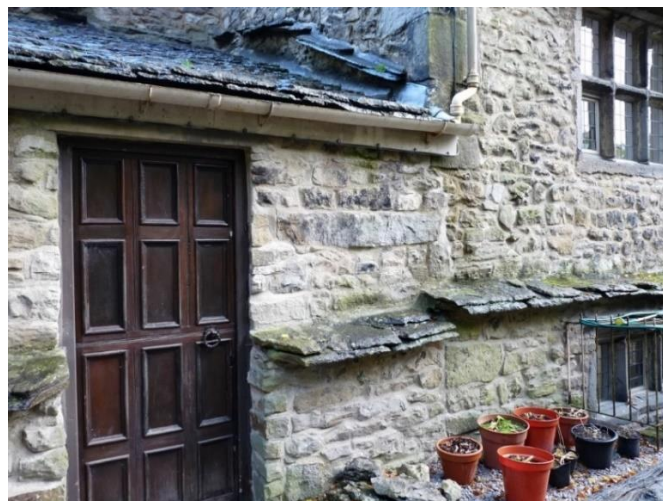
On the rear wall, there is only one instance of a straight joint in the masonry which could be evidence for phasing; this is at first floor level between the rear east wall of the stair tower and the outrigger to its south side (Fig.14). On initial inspection this suggests that the upper floor of the outrigger is an addition, but the south window to this room has the same form as others on the building and is characteristic of the late 17<sup>th</sup> century; it is feasible that this joint relates to a phase in the constructional sequence when the builders were raising the stair tower (a key element) followed by the outrigger (a secondary element). The upper floor of the south-east outrigger may have closely followed the building of the tower.

*Fig.14: tabling and the masonry joint between the stair tower and south-east outrigger. The doorway is an insertion*

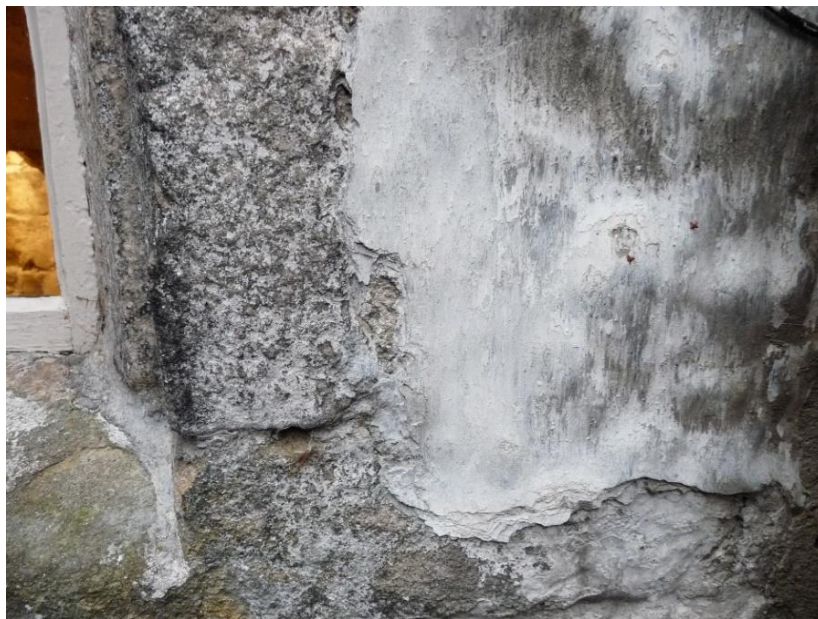
When first built, it is possible that at least some of the external masonry was concealed by a finish of lime-wash that would have unified the elevations and protected the masonry and joints from weather. If the front elevation had also been lime-washed this would have accentuated the effect of the fenestration and other architectural features, but the potential for this has not been investigated. Layers of lime-wash have survived on the north elevation at a lower level; it is probable that lime-wash was maintained on this wall to lighten the dark service yard behind the north outbuilding. This elevation has cementitious mortar on higher levels.

*Fig.15: layers of lime wash on the north elevation*

Parts of the exterior masonry may have been lime-washed in the past; before major repairs are carried out to the elevations, it is worth considering whether parts of the structure would benefit from lime-wash or render, to protect the fabric and reinstate a traditional finish. This may require some sampling and specialist advice.

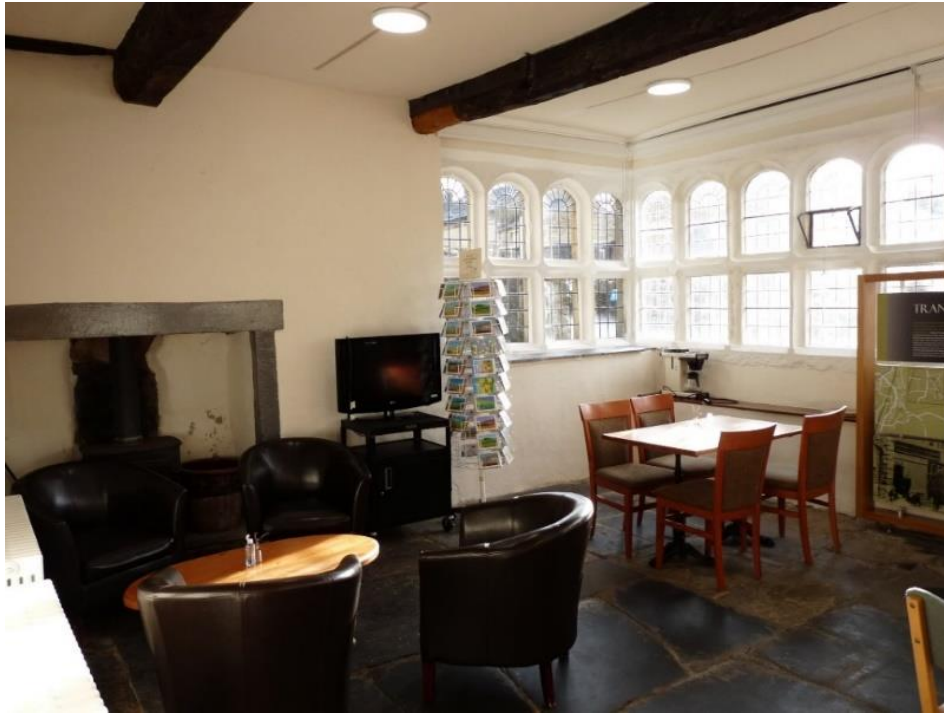
The room's key features are the mullioned and transomed windows that fill the west wall and wrap around the returns, particularly to the south. A south doorway inserted in the 19<sup>th</sup> century was removed and the window restored after 1996 by the NCBPT. The room has a slate floor, walls and ceiling are plain plastered (renewed after 1996), with chamfered beams (keyed for missing plaster). Stone corbels carved with stylised flower motifs carry sleeper beams on the west wall.

The fireplace on the south wall has a plain 19<sup>th</sup> century stone surround; the form of the original parlour chimneypiece is not known but may have been larger and of similar design to stone chimneypieces on the first floor (eg. in F5). The room originally extended to the external east wall; the partitions forming the present lobby (G2) were installed after 1996 and replace

*Fig.16: the parlour from the north*

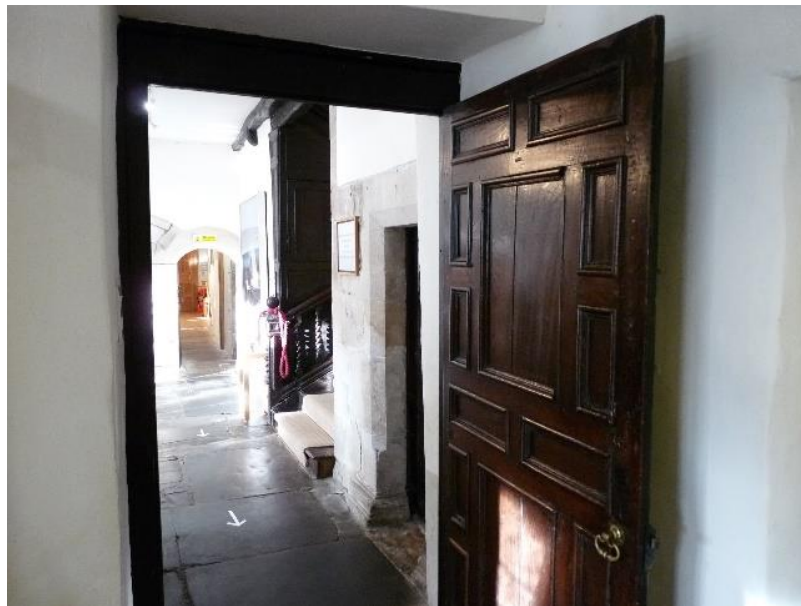
*Fig.17: parlour door, from G2*

G2 – Lobby and WC. This area was remodelled after 1996, when a 19<sup>th</sup> century staircase and partitions were removed, and the external doorway and stud partitions created. All finishes are modern. The north doorway into the lobby from the hall (G4) is the original doorway into the parlour, retaining a 17<sup>th</sup> century panelled door (Fig.17).

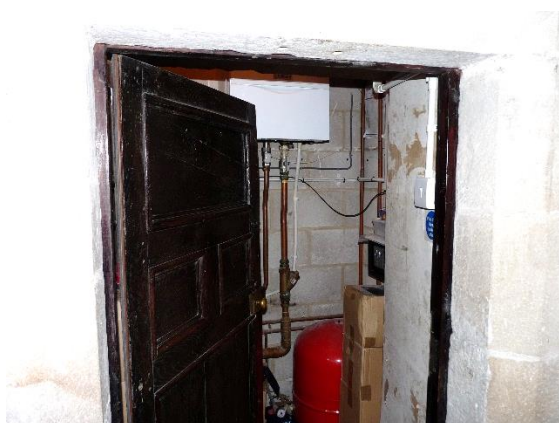
*Fig.18: historic door into G3 from G4*

G4 – Hall. The principal room on the ground floor, entered from the street via the lobby (G5) next to the fireplace. Internal historic doorways lead from this room to the north wing (G10), to the south wing (G2) and to the south-east room (G3); the latter two have 17<sup>th</sup> century doors but the doors into G5 and G10 are modern, restored after NCBPT bought the north wing in 2010.

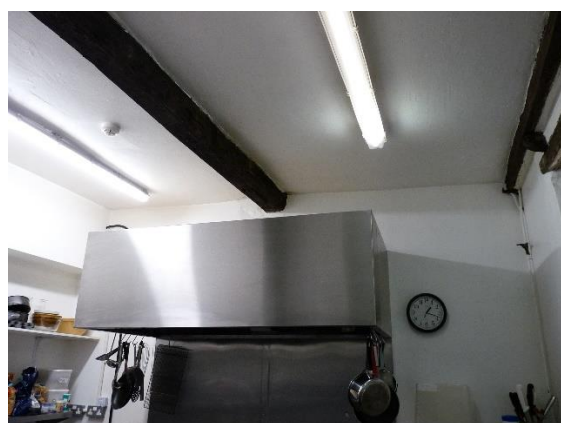
*Fig.19: G3 from the west.*

G3 – Kitchen. On the ground floor of the south-east outrigger, this small square room may have been a service room or small unheated parlour in the late 17<sup>th</sup> century house; it is not identifiable from the 1696 inventory. There is no evidence of a fireplace. It is lit by a mullioned and transomed window from the south, similar to the window in G12. A small inserted window on the east wall was blocked after 1996. The original doorway into the room was from the hall (G4); this has a chamfered stone surround and a panelled 17<sup>th</sup> century door which now serves a small plant room (modern). The doorway to the south of this from the lobby (G2) is a later insertion, perhaps 19<sup>th</sup> century or earlier. The room was adapted as a catering kitchen after 1996 and all finishes are modern. The ceiling beam is not moulded and may be re-used.<sup>50</sup> As in the rest of the building, the floor above is supported on a sleeper beam, set against the south wall and carried on shaped timber corbels (Fig.19). Stone corbels on the west wall, supporting the fireplace in the room above (F3) were recorded by Rodwell.<sup>51</sup>

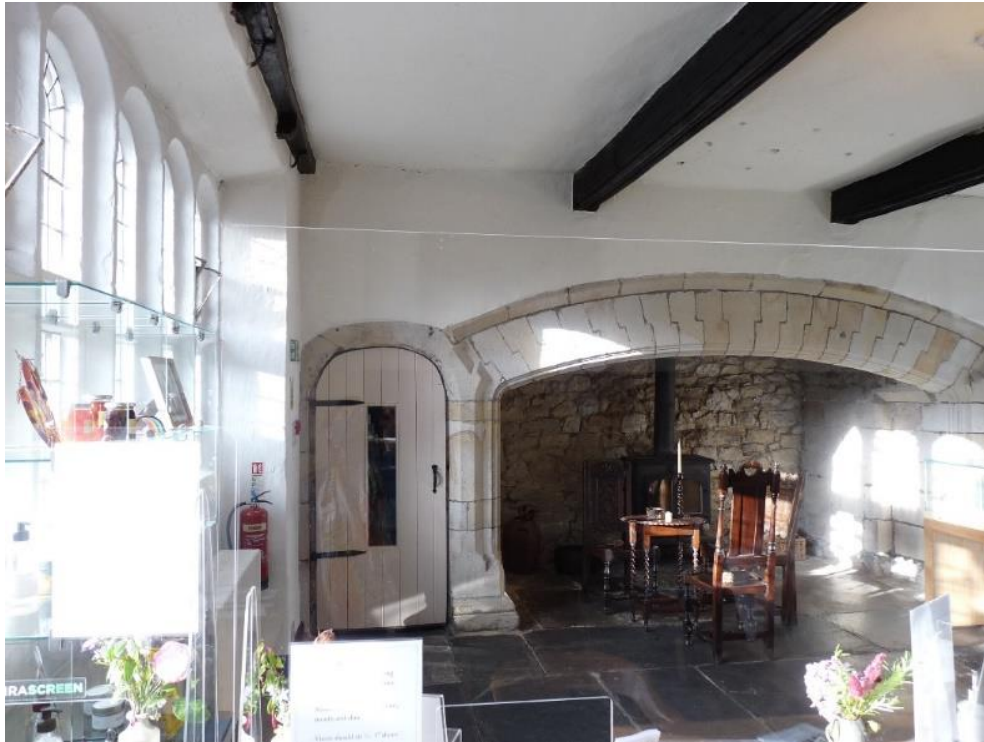
*Fig.20: the hall from the south*

The principal staircase (G6) is off the east side of the hall. The room is lit from the west by an 8-light mullioned and transomed window. A large stone fireplace dominates the north wall; this has a joggled segmental lintel (with Arabic assembly numbers incised on the back of each voussoir), moulded jambs and is flanked by stone arched doorways, an arrangement feature also seen in other Pennine houses of this date.

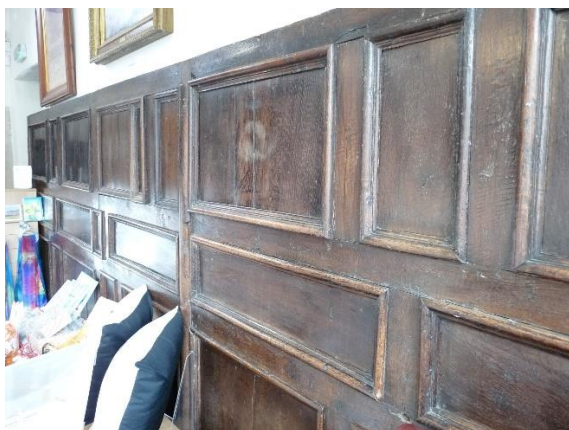
*Fig,21: re-set panelling to south wall*

The hall floor is of slate flags, and walls and ceiling are plain-plastered. The oak panelling to the south wall is re-set, and is similar to the small vertical section of panelling on the east wall next to the staircase; it is probable that the whole room was originally panelled and may also have had a decorative plaster ceiling. The floor above is carried on two ceiling beams, moulded to the same detail as the fireplace jambs, with sleeper beams to the west and east walls on timber corbels and wrought-iron brackets (latter to south wall only).

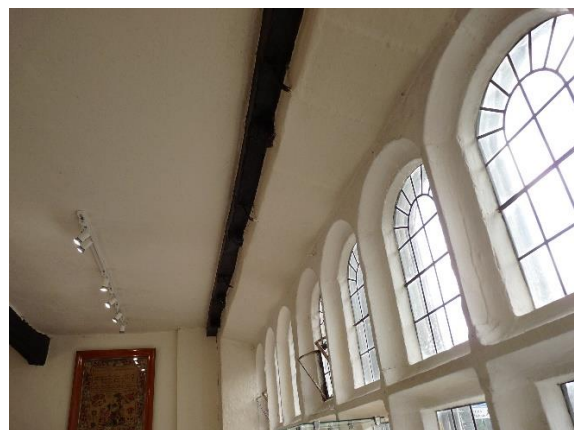
*Fig,22: hall window and sleeper beam*

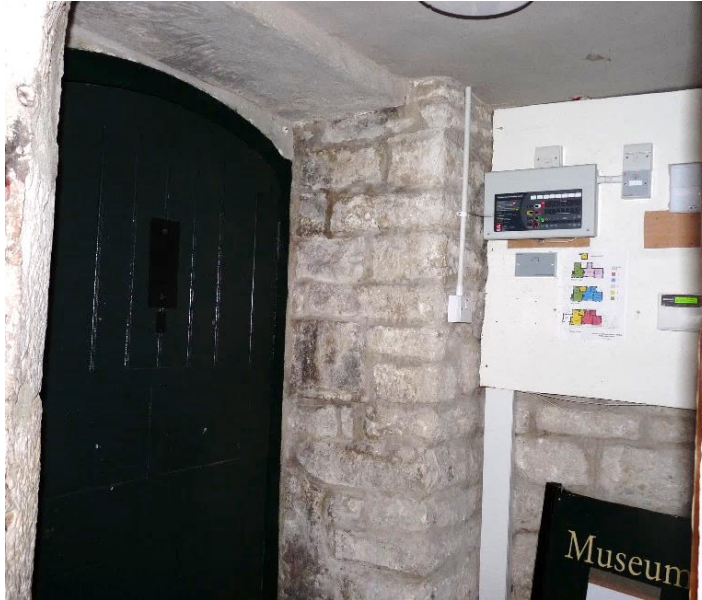
*Fig.23: hall entrance lobby from the south-east*

G5 – Hall lobby. The lobby is between the west side of the hall chimney breast and the front doorway. The door from the street is a 19<sup>th</sup> century replacement for the original 17<sup>th</sup> century door, hung within a stone rebated doorway. The lobby has a slate floor and plain-plaster to the renewed ceiling. The walls are now fair-faced stone, but historically the walls would have been lime-plastered.

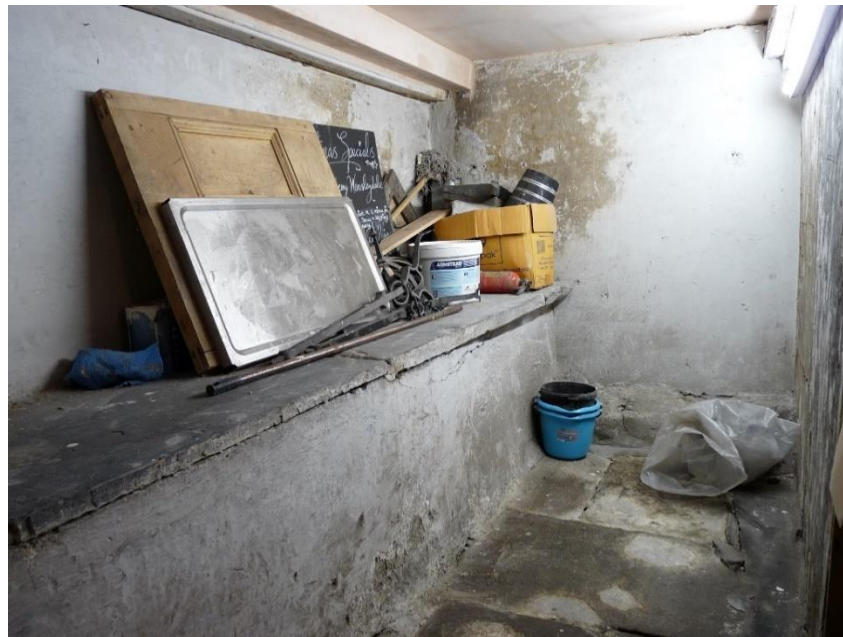
*Fig.25: 'cellar' below the staircase*

G7 – Under-stairs store. This may be the 'cellar' listed in the 1696 inventory; although this space, partly beneath the half-landing, is not below ground floor level, this is a usual location for a cellar in houses of this plan. It is accessed via a 17<sup>th</sup> century oak door, from the

south side of a former service room (G8); the outer door is a modern addition. Inside, the space has a stone floor and a wide stone shelf built into the east wall, where there is a small blocked window. Walls are lime-plastered.

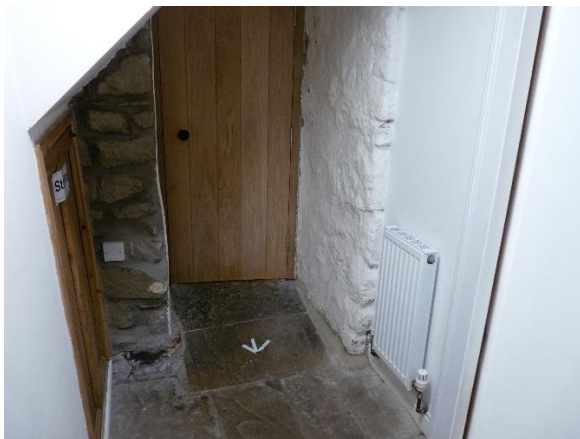
*Fig.26: lobby and door into G12, from the south*

G8 – WC's and lobby. This area in an outrigger has been altered in several phases, but may have been one of the unheated service rooms referred to in the inventory, perhaps the milk room listed in the 1696 inventory. There is no evidence for a fireplace. The room is entered through a chamfered stone doorway from the passage that runs from the former kitchen (G10) to the hall (G4). The doorway on the south wall leads to the under-stairs store (G7) and the doorway to the north to the former heated service room (G12), the latter possibly a later insertion. In the thick section of wall east of this doorway the soffit of part of a former stone staircase set into the wall is visible; this staircase would have run from the back kitchen (G2) to the floor above. It was removed or blocked at an unknown date, and is not legible on the north side of the wall. The room has a 2-light cavetto-mullioned window to the east wall (previously this was a 3-light window, altered in the 19<sup>th</sup> or early 20<sup>th</sup> century). A timber staircase (G9) against the west wall of the space serves the rooms in this outrigger. The partitions and fittings for two WCs on the east side of the space were installed as part of refurbishment since 2010.

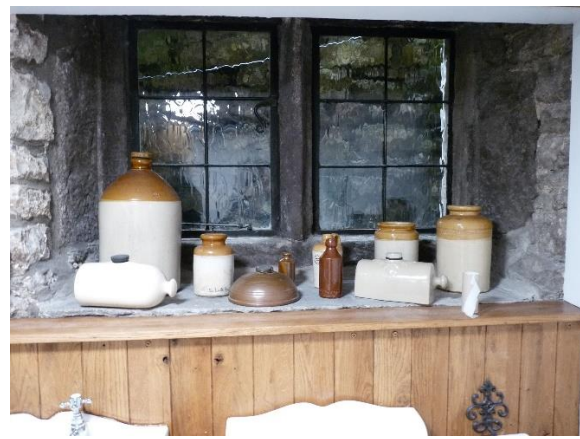
*Fig.27: window in WC*

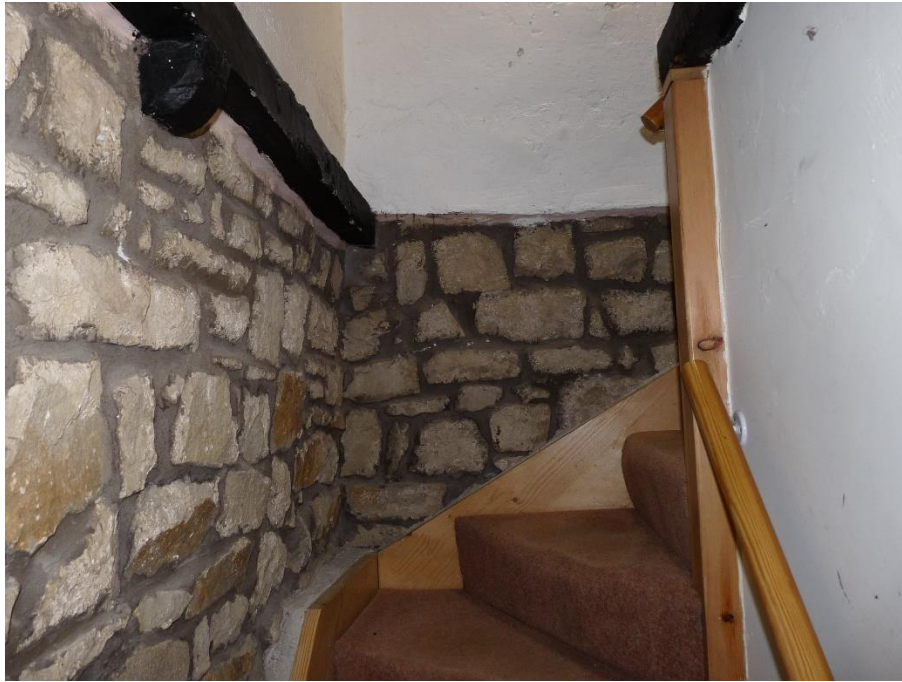
G9 – Secondary staircase. A steep narrow staircase runs against the west and north wall of the outrigger between the tower and the north wing, serving two upper floors (F10 and F11 and S10). The staircase is a recent reconstruction of the previous staircase, made of pine and enclosed within a timber partition. The door at the foot of the staircase is modern. Walls are fair-faced stone, but would have been lime-plastered. The staircase appears to be a 19<sup>th</sup> century insertion into an earlier service room; the sleeper beam on the west wall is evidence for the first floor in the outrigger, which extended across the staircase area.

*Fig.28: staircase from the south*

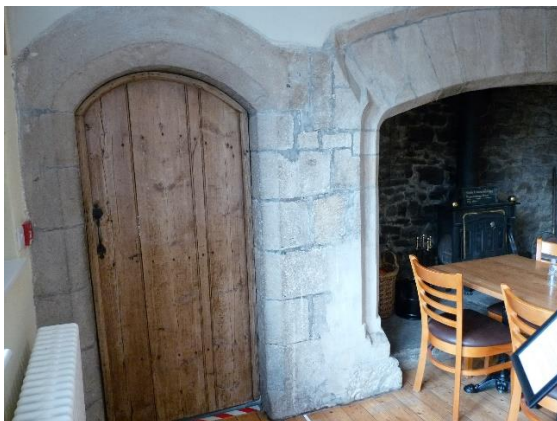
*Fig.30: inner lobby door*

G11 – Café lobby. Now used as the main entrance into the building, this is similar in form to the lobby to the hall (G5), adjacent to the west side of the kitchen chimney breast. The door from the street is a late 19<sup>th</sup> century replacement for the original 17<sup>th</sup> century door, hung within a stone rebated doorway. There is a small blocked window on the north wall, with lime-washed reveals. The lobby has a slate floor, the walls are now fair-faced stone, but historically the walls would have been lime-plastered. There are mason's mark in the form of an incised 'k' on the stone jamb to the inner doorway. This has an historic pine door, probably late 18<sup>th</sup> or 19<sup>th</sup> century, reinstated by Mark Rand in c2002.

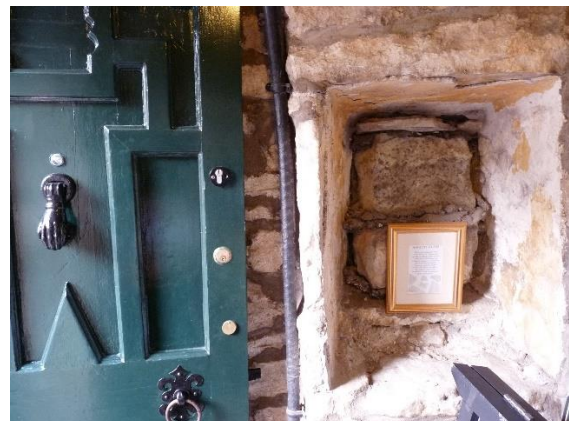
*Fig.31: outer door and blocked north window*

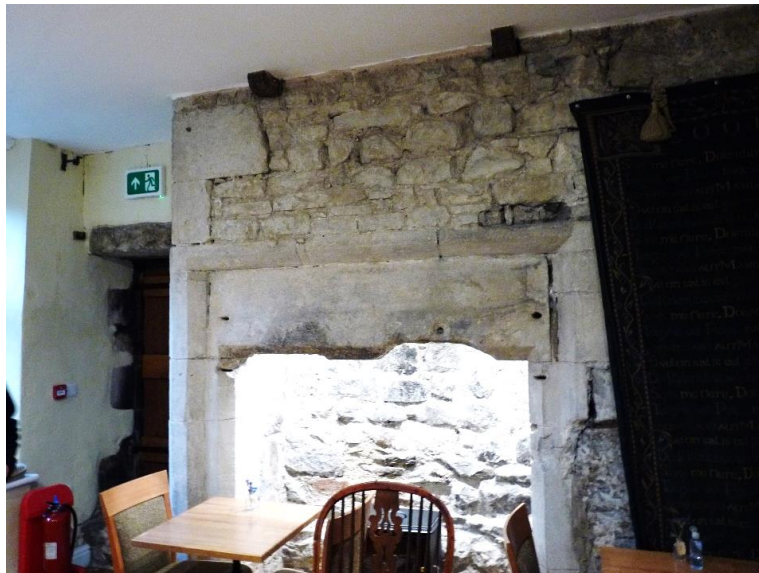
G12 – back kitchen. This room in the east side of the north wing would have been part of the services in the 17<sup>th</sup> century house; it is not clearly identifiable from the 1696 inventory but could have been the brewhouse at that time. The room has an external doorway on the east wall, north of the fireplace; the chamfered stone surround is 17<sup>th</sup> century and was re-opened in c2002 after being blocked in the early 20<sup>th</sup> century, the door is modern.<sup>54</sup> The fireplace has a 17<sup>th</sup> century chamfered stone surround, partly damaged by later alterations; the bread oven discovered on its south side in c2002 appears to be a later insertion, perhaps 18<sup>th</sup> century. The timber corbels on the east wall are for the sleeper beam, hidden above the modern plaster ceiling. The room is lit by a mullioned and transomed window on the north wall, of similar to pattern to the window in G3. The doorway on the south wall leading to G8 appears to be an insertion; this wall has been disturbed but there is no evidence for the former staircase visible on its north face. The stone walls are now partly fair-faced, following plaster removal in c2002. The west wall is a modern partition, and the floor has a modern pine floor.

*Fig.32: fireplace in G12*

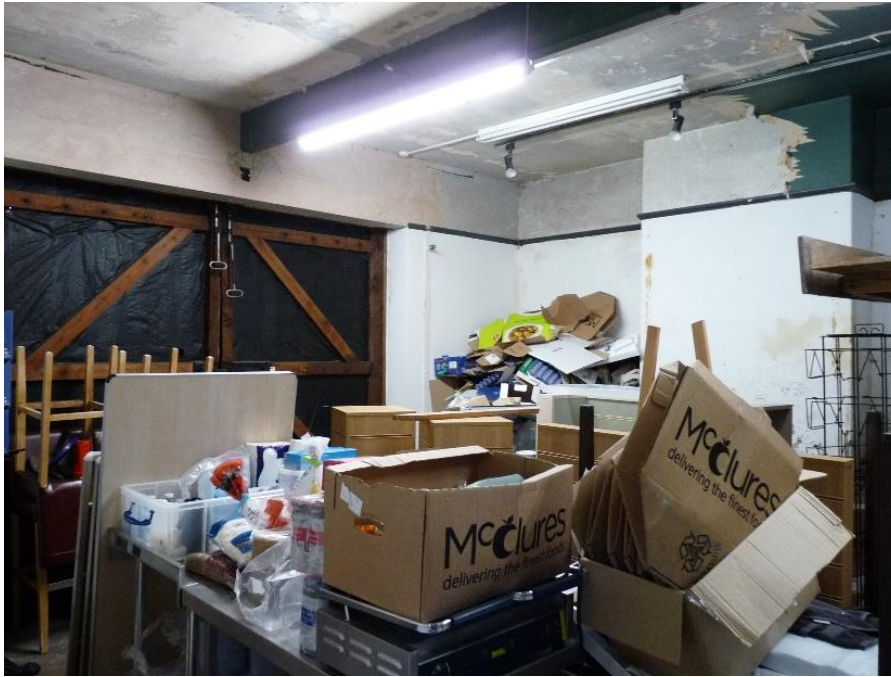
*Fig.33: garage interior from the south-east*

The garage interior is one space, with a chimney breast on the north wall with a blocked fireplace. The window to the east wall has a timber hopper light, probably mid-20<sup>th</sup> century. The half-glazed door adjoining the window is modern, but is set in a chamfered 17<sup>th</sup> century stone surround, perhaps re-set. The walls and ceiling are plastered and papered, with a picture rail, part of 20<sup>th</sup> century finishes, probably relating to its use for Barclays Bank in the 1970s. The floor is concrete.

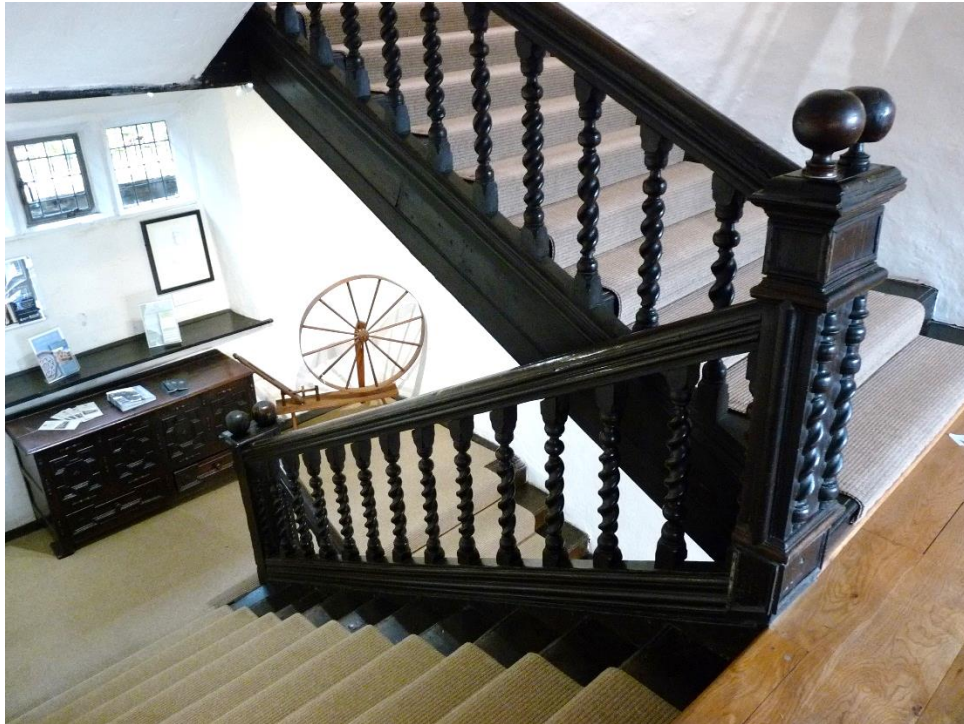
F1 – Principal staircase. As described for G6, the staircase has a half-landing lit by a mullioned and transomed window. The flights from the first to second floor have been largely renewed in pine, but otherwise the details are the same as the staircase from the ground floor.

*Fig.34: staircase from first floor*

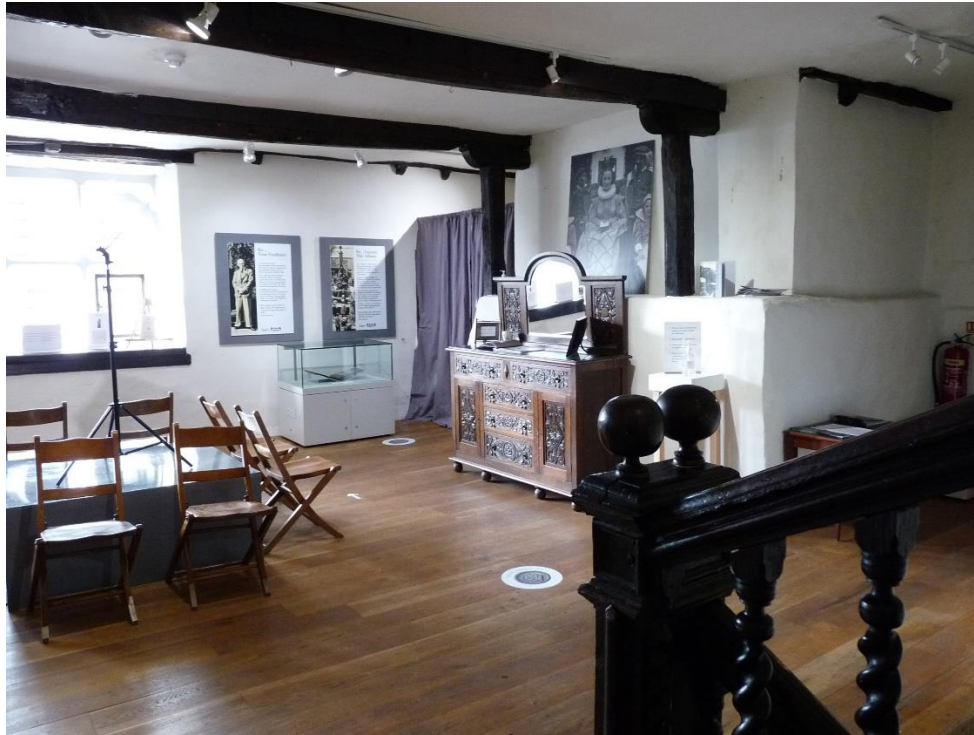
*Fig.35: hall chamber from the south-east*

F2 – Hall chamber. The room is reached from the staircase (F1) which opens directly into the room; this is probably the 17<sup>th</sup> century arrangement, although partitions for passages were later inserted and removed. The room is lit by a mullioned and transomed window, with a small window to the north that lit a closet next to the north chimney breast. The closet is without a partition. There is no evidence for a fireplace in the north chimneybreast which contains the flue from the hall fireplace; the corbelled fireplace is to the south, altered with a moulded stone chimneypiece (painted), perhaps inserted in the early 18<sup>th</sup> century. The floor above is carried on chamfered beams with chamfered posts and timber corbels to the north ends, and sleeper beams to west and east walls, on timber corbels. A doorway with re-set chamfered lintel leads into the north wing, with a panelled door (17<sup>th</sup> century style, but possibly a 19<sup>th</sup> century replica). The corresponding door to the south wing is modern. The doorway into the outrigger (to F3) has a 17<sup>th</sup> century 2-panel door, but the architrave is later. The room is part of the museum, with a recent oak floor and plaster finishes.

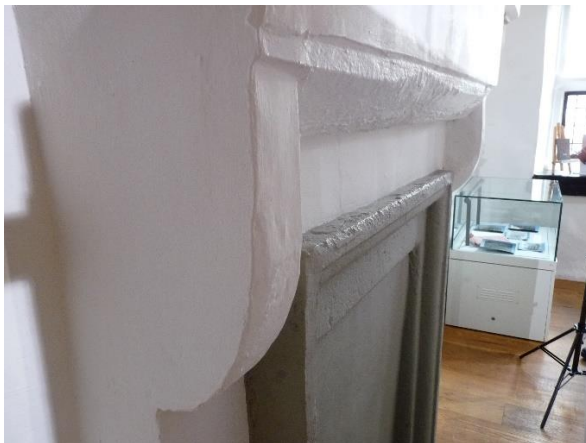
*Fig.36: hall chamber fireplace*

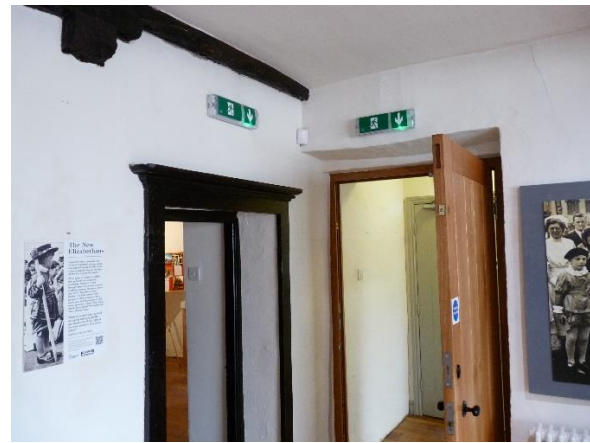
*Fig.37: doorways in south-east corner*

F3 – South-East chamber. This room may have been one of the secondary chambers listed in the 1696 inventory, but other writers suggest it is an early 18<sup>th</sup> century addition.<sup>55</sup> It has two doorways from the west; the south of these is probably an insertion and blocked to form a recess (from the stair landing F4). The 2-panelled door from F2 is late 17<sup>th</sup> or early 18<sup>th</sup> century. The external east doorway is a 20<sup>th</sup> century insertion. The stone fireplace on the west wall has a plain lintel and chamfered jambs; the lintel on corbels appears to be an

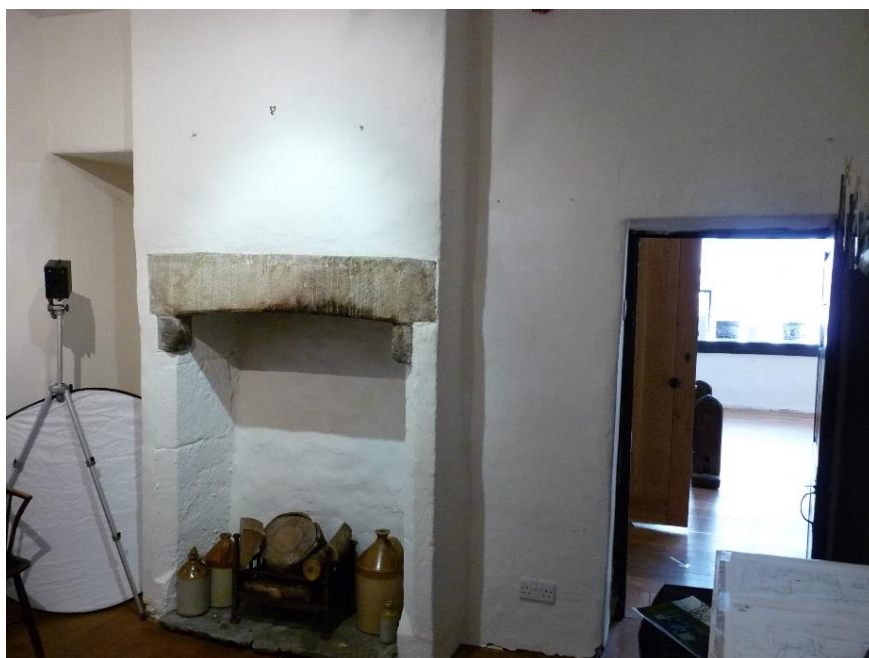
alteration. The jambs and the mullioned and transomed window on the south wall are characteristic of the late 17<sup>th</sup> century and match other chamfered stone features on the building. The oak floor is modern.

*Fig.38: fireplace in F3 and doorway into hall chamber*

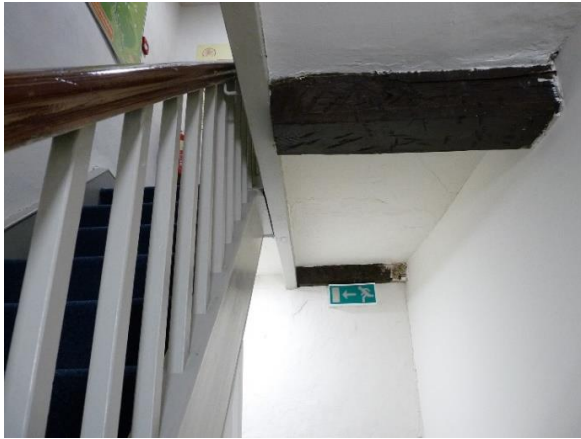
*Fig.39: truncated beams for staircase*

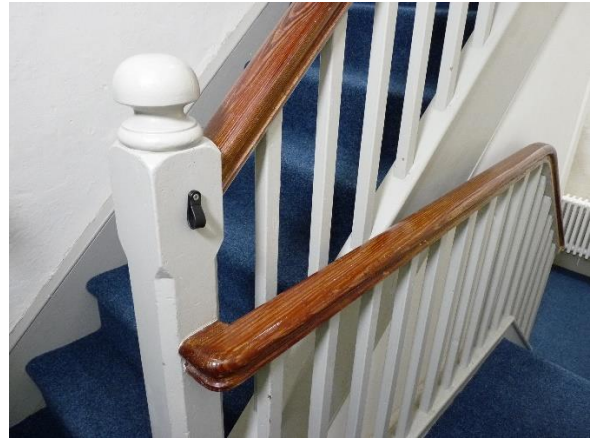
*Fig.40: staircase details*
