# **The Folly, Settle, North Yorkshire**

## **Statement of Heritage Significance & Scope for Change**

The Folly, Victoria Street, Settle, BD24 9EY

Statement of Heritage Significance & Scope for Change

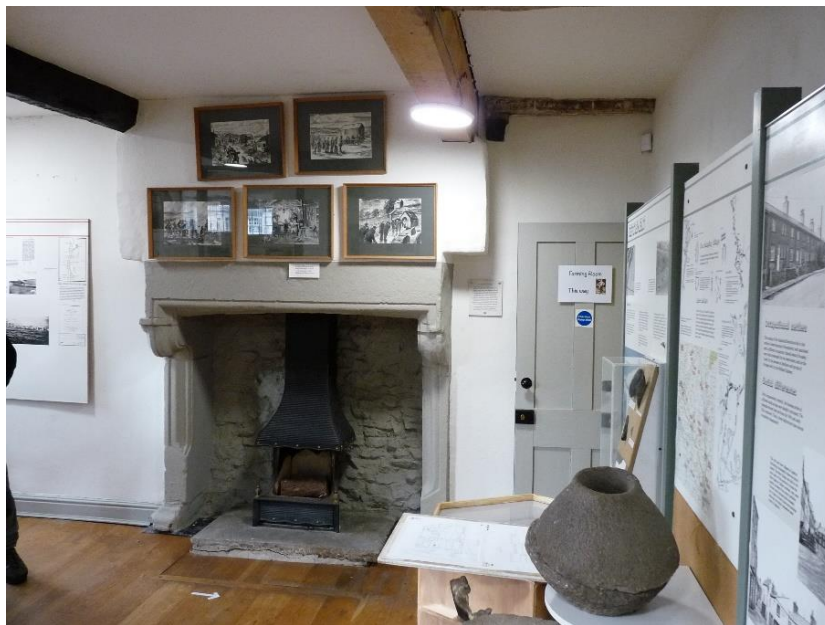
*Fig.41: parlour chamber from the south*

F5 – Parlour chamber. Now used for the museum, this room occupied the whole of the first floor in the south wing before the staircase (F4) and partitions was inserted. It was originally accessed via the doorway from the hall chamber (F2), which had been blocked until re-opened by the NCBPT. The panelled door into the room from the staircase landing (F4) is 19<sup>th</sup> century. The room is lit by mullioned and transomed windows from the west, with north and south corner windows. The stone fireplace is on the north wall, with richly moulded jambs and corbels. Two beams carry the floor above; the west one is chamfered and original, the east one is a recent oak replacement. Timber corbels on the west wall carry sleeper beams. The plaster finishes and timber floor are part of the recent refurbishment.

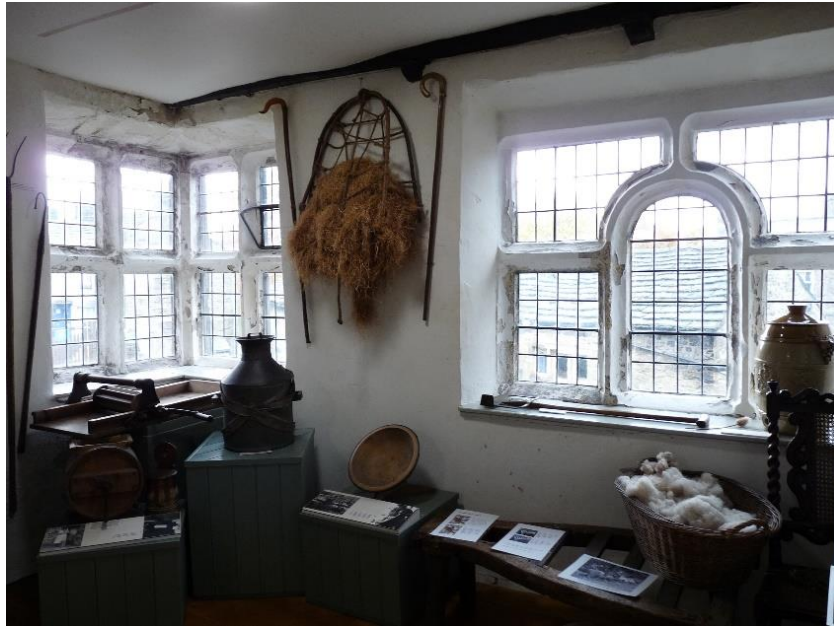
*Fig.42: parlour chamber windows from the north*

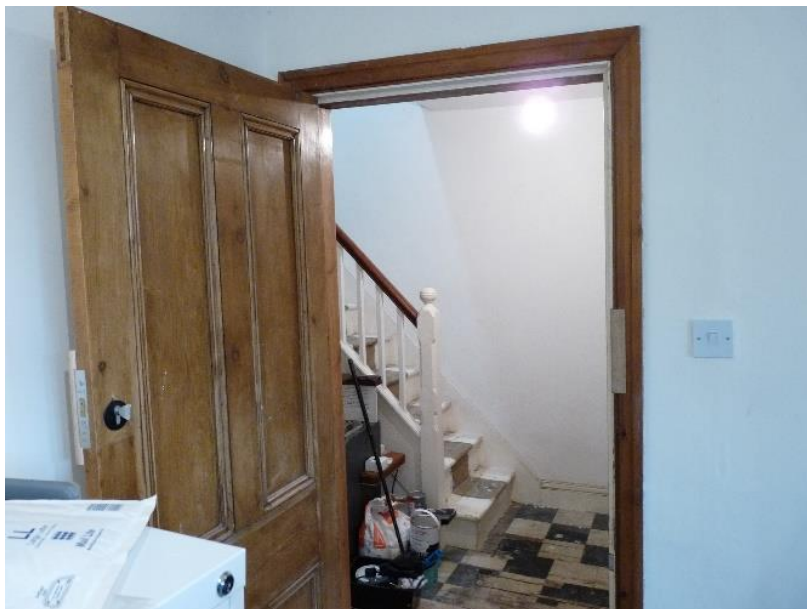
F6 – Staircase in north wing. This secondary staircase was inserted in the 19<sup>th</sup> century, at the same time as the south staircase; both have the same joinery details. The stairs and lobby are within a compartment (stud partitions) which encroaches on the kitchen chamber and the former chamber to the east of the north wing; this probably entailed the removal of an earlier partition. The pine staircase has a plain design with closed strings, stick balusters, moulded handrails and chamfered newels, typical of late Victorian domestic joinery.

*Fig.43: staircase from F9*

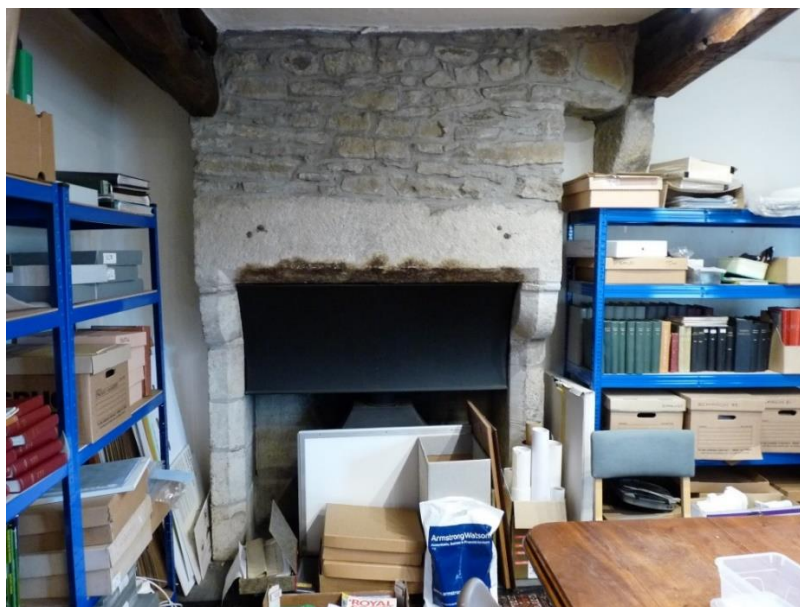
F7 – Kitchen Chamber. This room is on the front of the north wing, with a closet (F8) off the north-west corner. It now houses the Settle-Carlisle Railway Archive. The west-facing windows are similar to those in the parlour chamber, wrapping round the north and south corners of the wing. In the 17<sup>th</sup> century the room was accessed from the hall chamber (F2), but is now reached via the staircase lobby (F6), which has a pine panelled door with glazed over-light, probably installed in the early 20<sup>th</sup> century. The room has a corbelled stone fireplace on the south wall, with chamfered details; a moulded stone corbel projects from the wall to the west of the fireplace, to carry the chamfered beam (one of two) to the floor above and there are additional timber props. Timber corbels on the west wall carry sleeper beams. The timber floor is hidden by carpet, but in c2002 there were oak boards here.<sup>57</sup> Walls and ceiling are plain plastered, but plaster has been stripped from above the fireplace (Fig.44).

*Fig.44: kitchen chamber, fireplace from the north*

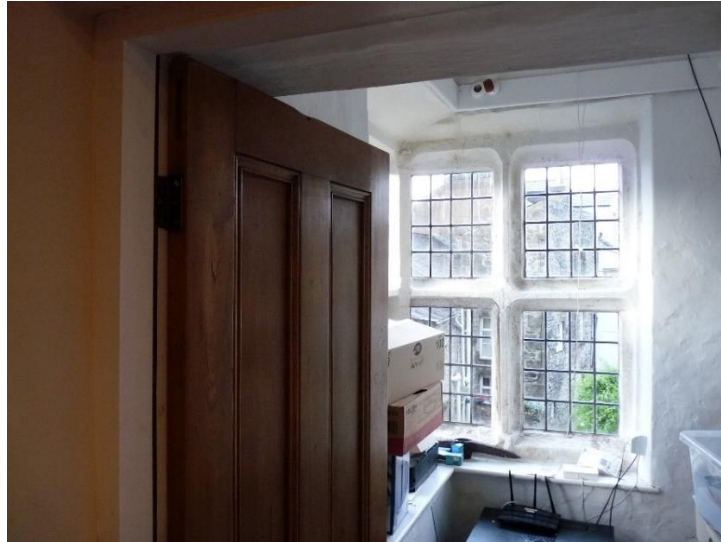
F8 – Closet off kitchen chamber. This may be the closet mentioned in the 1696 inventory. It has a corner window giving views north and west (Fig.45). The unheated small room has a 4-panelled pine door (fitted since 1971) and plain plaster finishes. There are no other historic fittings apart from the windows.

*Fig.45: closet off kitchen chamber, from the south*

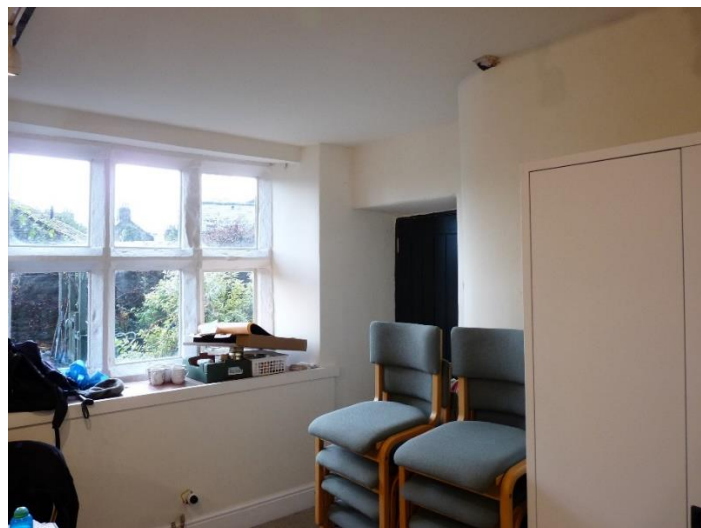
F9 – north-east meeting room. This room may have been one of the secondary chambers listed in the 1696 inventory. It has two internal doorways; the west of these is part of an inserted partition related to the south wing staircase and the south doorway was probably cut through the internal wall, at an unknown date. In the 17th century the room would have been entered via a door in a partition wall that separated it from the kitchen chamber, probably removed when the staircase was inserted (F6).

*Fig.46: east room in north wing, from the south*

The external east doorway is a 19<sup>th</sup> or 20<sup>th</sup> century insertion. There is a blocked fireplace on the east wall; the chimney breast has timber corbels relating to sleeper beams for the floor above. The mullioned and transomed window on the north wall is late 17<sup>th</sup> century, similar to the window in F3. The timber floor is hidden under a carpet; date not known. All plaster finishes are modern.

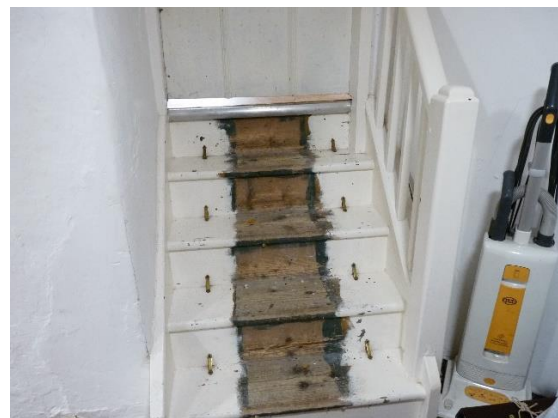
*Fig.48: stairs up to F9, from the landing*

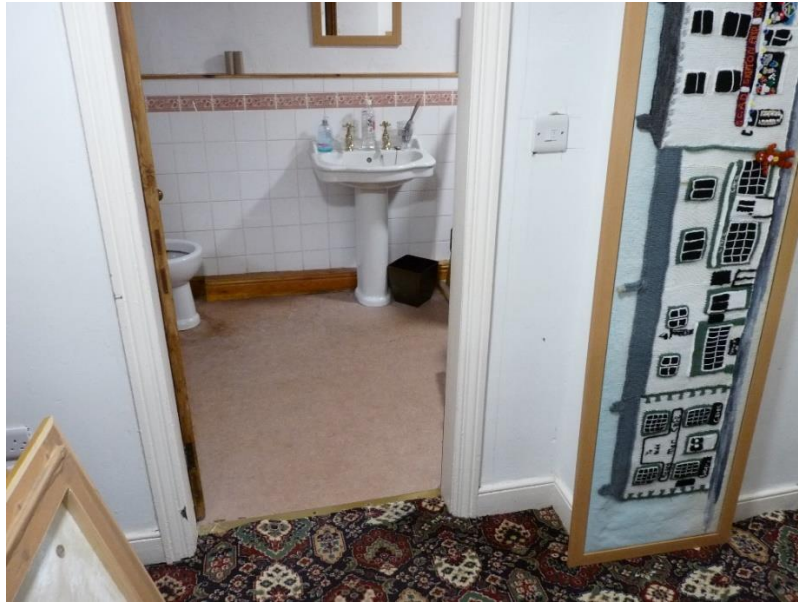
F11 – Bathroom in the north-east outrigger. The bathroom was created by inserting a partition across the space, which divides the 3-light mullioned window; the south two lights serve the bathroom. The current partition appears to be late 20<sup>th</sup> or early 21<sup>st</sup> century, but may be on the line of a 19<sup>th</sup> century partition. Corbels on the east wall support a sleeper beam for the floor above (S10), indicating that the ceiling level is unchanged from the 17<sup>th</sup> century. The bathroom fittings are modern. The date of the floor structure is not known.

*Fig.49: bathroom from the landing to the north*

F10 and F11 are previously altered areas, where a former service room on this floor has been subdivided. The staircase from the ground floor is partly a recent replacement for the pine 19<sup>th</sup> century staircase; as this has relatively low significance, there is scope to remove it without causing harm to this part of the building. The impact of providing improved access to the first and second floor (S10) will depend on the design and whether this would entail disturbing masonry or only joinery structures. Further investigation of the floor structures and adjoining masonry walls is recommended, to establish their significance.

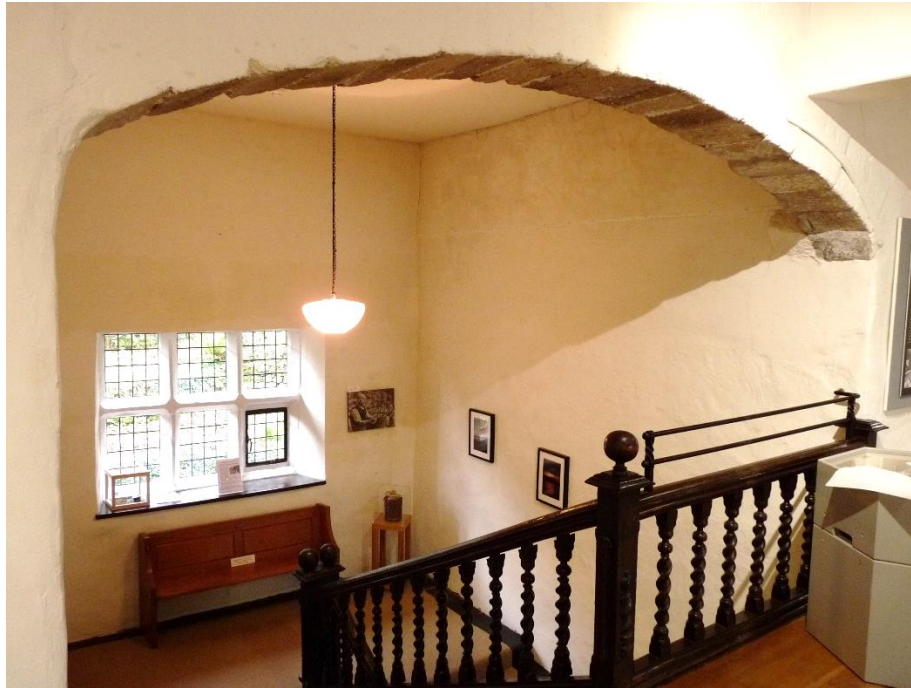
S1 – Principal staircase. The staircase from the ground floor terminates at the second floor (S2); it has a consistent character for its full height, with oak treads, closed string, moulded handrail and rectangular or square newels with ball finials. All of the treads at this level have been replaced in matching oak except for three treads on the final flight. The landing section of balustrade is a late 20<sup>th</sup> century replacement to match the rest of the staircase; prior to this refurbishment, the landing balustrade was to a different plainer design (just seen in one of the 1971 RCHME photographs – ref.6423-054). A semi-elliptical stone arch bridges the top of the staircase, carrying the west wall of the tower above. The ceiling over the staircase was installed in the 1960s, with an access hatch; the staircase was open to the tower before this.<sup>58</sup> The landing is lit by a mullioned and transomed window. The walls are plain plastered.

*Fig.50: the staircase from the second floor*

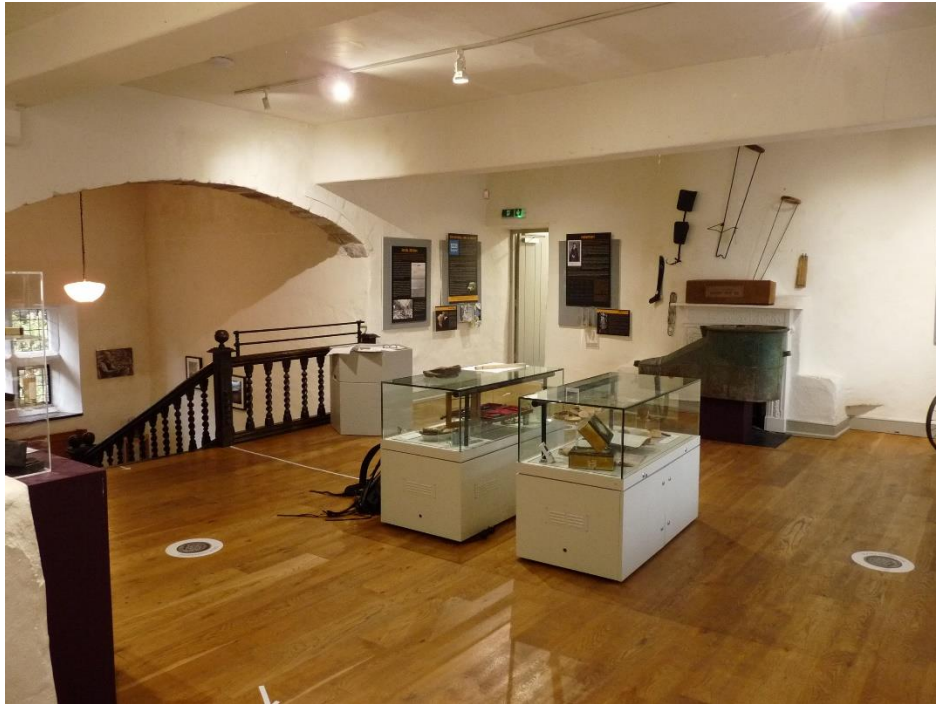
*Fig.51: S2 from the north-west*

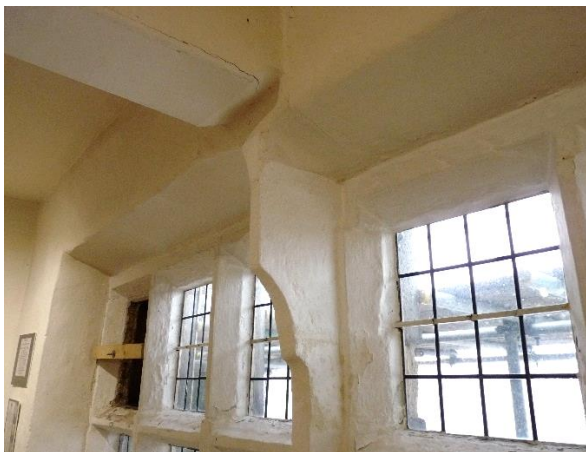
*Fig.52: stone king mullion corbel to tie-beam*

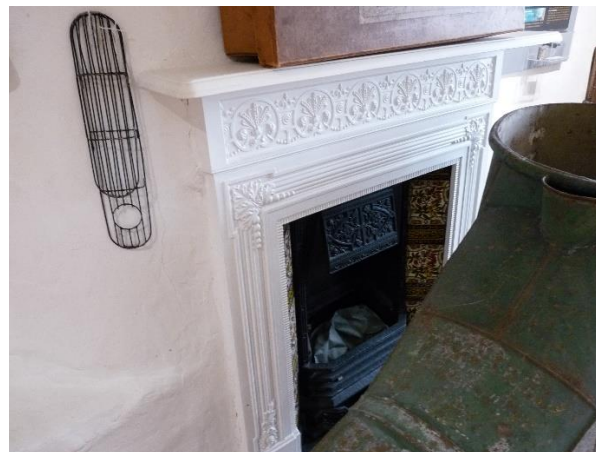
*Fig.53: inserted late 19<sup>th</sup> century fireplace, at south end of room*

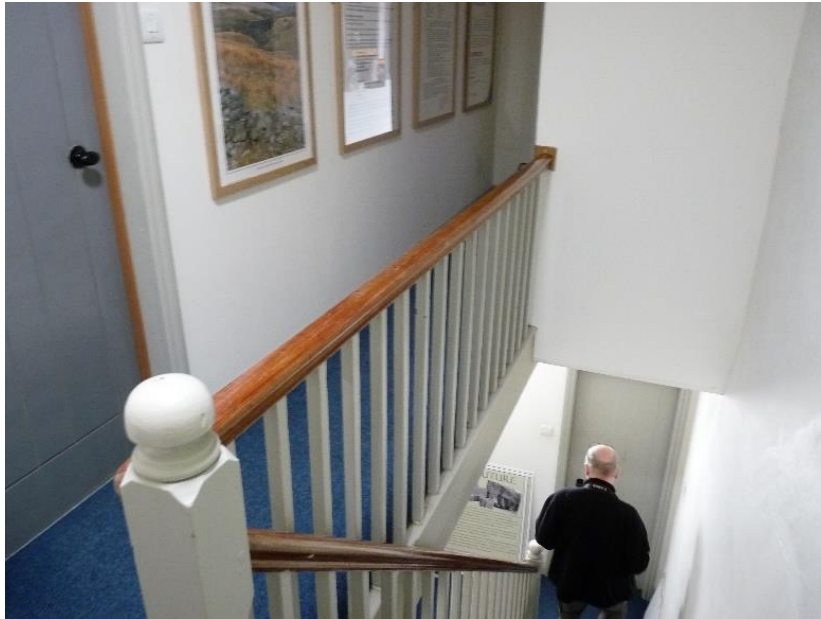
S3 – Stair landing in south wing. The 19<sup>th</sup> century staircase in the south wing has a plain balustrade to the landing (of same design as rest of staircase). The inserted partition for the staircase subdivides the top floor of this wing. The doors off the landing are modern timber. Walls and ceiling are plain-plastered. The floor is carpeted and it is not certain whether the floor structure is also 19<sup>th</sup> century; some opening-up is recommended to check this.

Fig.54: staircase and landing in south wing, from the south

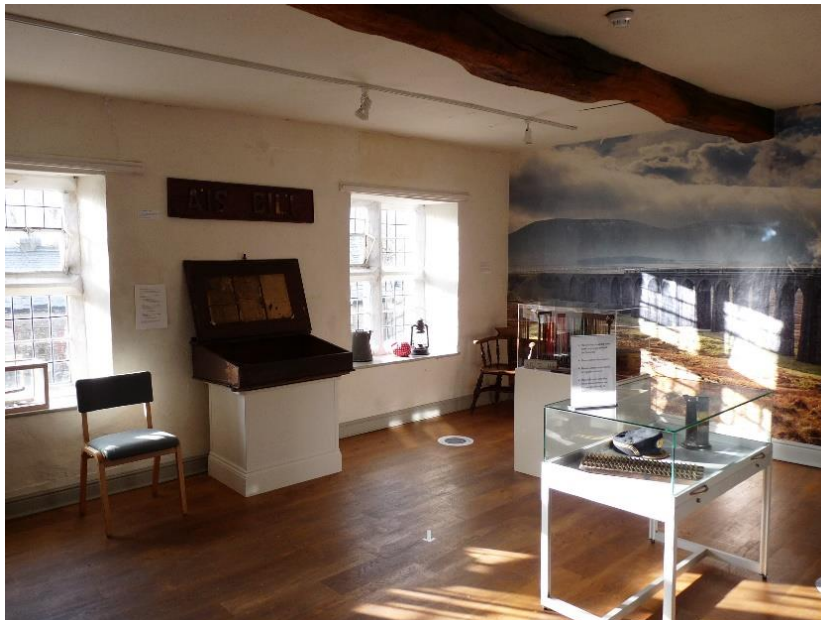
S4 – South wing room. This room displays Settle-Carlisle Railway material. It is lit by two cross windows facing west. The original doorway into the room was from S2; prior to the staircase being inserted, this room filled the south wing at this level. There is no evidence that the room was ever heated; the convex chimney breast on the north wall serves the flue from the parlour chamber fireplace. Two chamfered beams (heavily de-frassed) span from north to south; these are the tie beams to the roof trusses. Walls and ceiling are plain-plastered and the floor has modern oak boards.

Fig.55: Settle-Carlisle Railway display room from the south-east

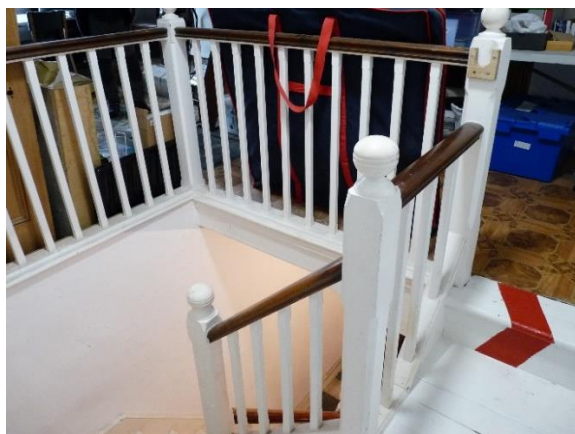
S5 - Stair landing in north wing. The 19<sup>th</sup> century staircase has a plain balustrade to the landing (of same design as rest of staircase, and staircase in north wing). The door off the south side of the landing into S2 is modern timber. Panelled pine doors into S8 and S9 are 19<sup>th</sup> century. No partition separates the top of the staircase from S6, the room to the west. Walls and ceiling are plain-plastered and the floor is of pine boards, with linoleum; the landing floor is one-step above the floor level in S6, raised when the staircase was built.

*Fig.56: top of staircase, from south-east*

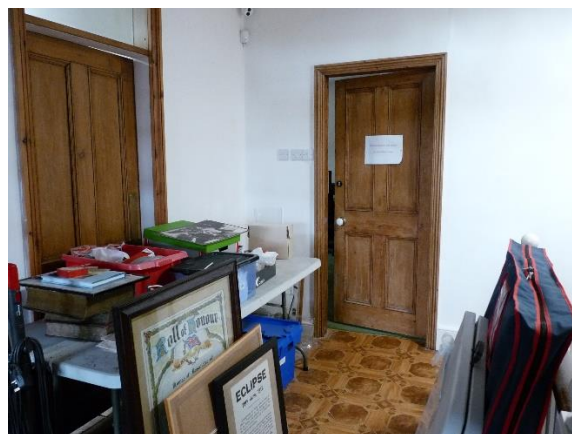
*Fig.57: doors to S8 and S9, from west*

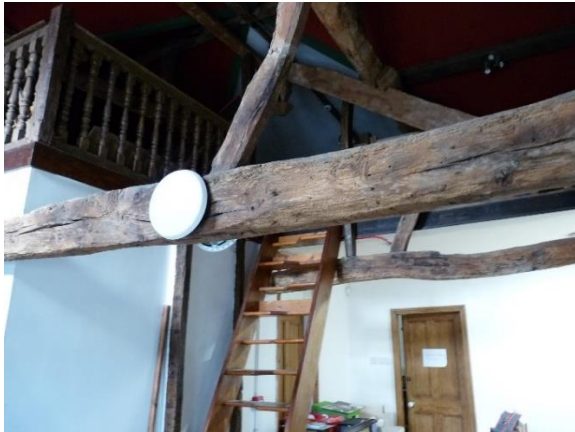
S6 – South room on top floor, north wing. This room was altered by the removal of the ceiling/attic floor and a partition in the late 20<sup>th</sup> century, to form the present L-plan room, open to the roof.<sup>60</sup> The floor is laid with wide hardwood boards, perhaps 17<sup>th</sup> century, with an over-laid later pine floor to the north-west corner of the room. A late 20<sup>th</sup> century ladder stair gives access to the attic space, over the north and east parts of the north wing. The walls are plain plastered up to the former ceiling height, with painted rubblestone above; the roof structure is visible (discussed below). There is no evidence that the room was heated; it was probably used for storage. The convex chimneybreast on the south wall contains the flue for F7 (kitchen chamber). The room is lit by two cross windows from the west. A 19<sup>th</sup> century panelled door leads to the closet (S7).

*Fig.58: roof trusses and ladder, from SW*

| S6 | medium to high | Much altered room, missing ceiling, C19 and C20 partitions. Potential to enhance significance by reversing some of changes. |

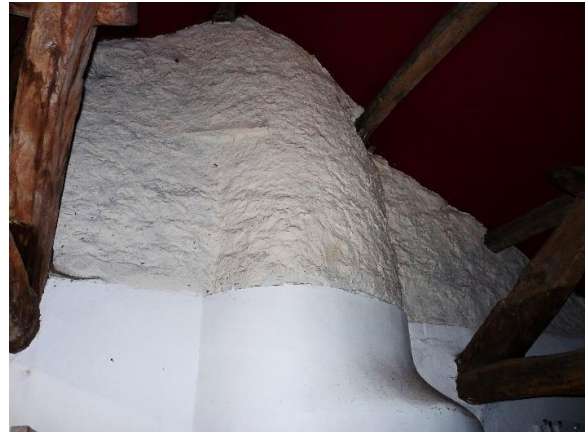
*Fig.59: back of the south flue, from NE*

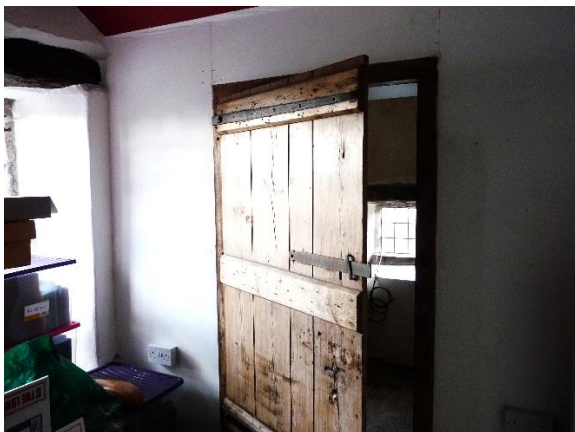
S7 – Closet. This small room is above the kitchen chamber closet, off the north-west corner of S6, next to the kitchen chimneybreast. The planked pine door is late 18<sup>th</sup> or 19<sup>th</sup> century and may be re-set; graffiti on the door may relate to workshop use.<sup>61</sup> The two small windows have stone lintels and surrounds, plastered reveals and face north and west. The walls and flat ceiling are plastered, and the floor is plywood.

*Fig.60: doorway to closet from S6*

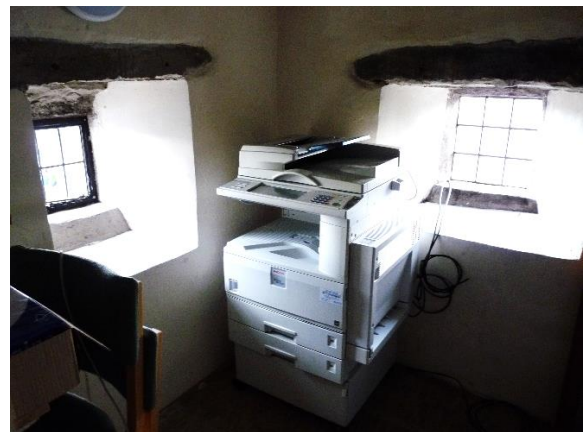
*Fig.61: closet from south-east*

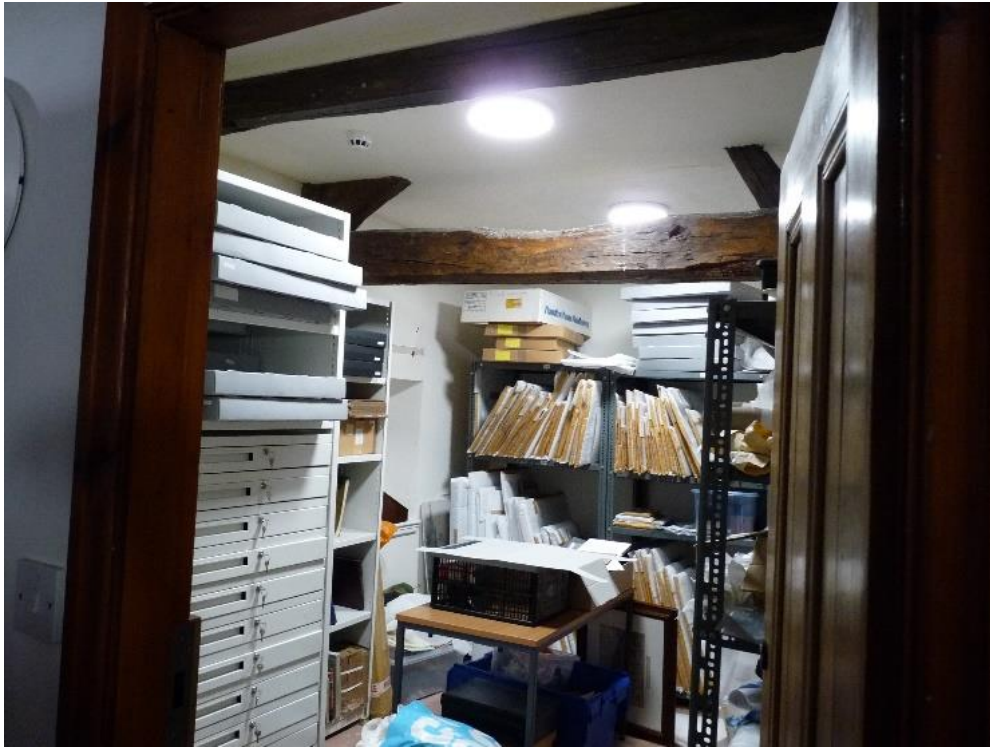
S8 – Archive store. This room was originally part of the large second floor room that originally filled the west front of the north wing. It is enclosed by studwork partitions to east, west and south, of 19<sup>th</sup> or late 20<sup>th</sup> century date. The room has two panelled 19<sup>th</sup> century pine doors, from the west and south, possibly re-set. The window to the north wall has a single-light that may be part of a larger blocked mullioned window; its external character suggests this is a 19<sup>th</sup> century inserted window, like the north window to S9. Walls and ceiling are plain-plastered and the floor laid with ply, with a chamfered beam to the

ceiling and the lower part of a roof truss visible below the ceiling. It is not known whether the floor structure consists of pre-19<sup>th</sup> century joists or is a later insertion.

*Fig.62: archive store from the west doorway*

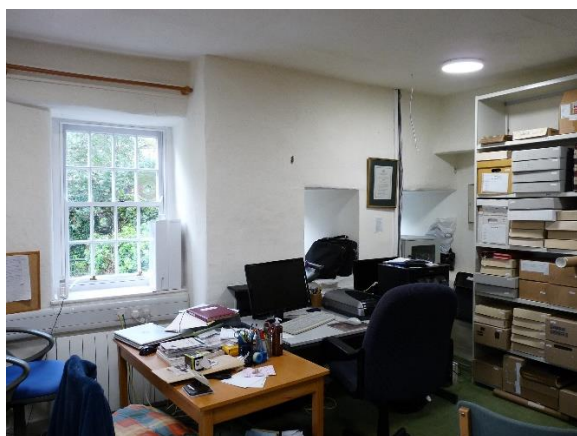
S9 – office to east end, north wing. The room, now used as an office, may have been part of a store room on the second floor of the north wing, with an external partly blocked doorway to the east gable-end. The room has been much altered, and it is not certain whether this room was originally separate from S5, S6 and S8, or whether the whole of the second floor of the north wing was one space, open to the roof. In place of the external east doorway there is a 16-pane sash window; this is a 20<sup>th</sup> century window, but may replace an early 19<sup>th</sup> century sash here. The 3-light mullioned window to the west wall is 19<sup>th</sup> century, with late 20<sup>th</sup> century joinery. The doorway from the landing (S5) has a pine 19<sup>th</sup> century door, in a stud partition below a plastered down-stand beam (encasing the tie-beam of a roof truss).

*Fig.63: altered east wall with former doorway to left*

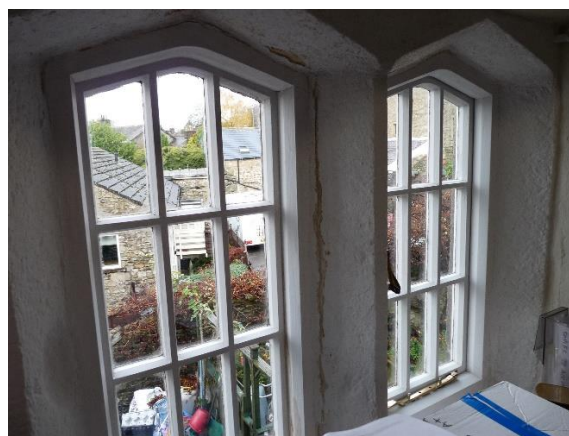
The room was not originally heated; the small Victorian cast-iron fireplace in the north wall was inserted into the chimneybreast serving the back kitchen flue (G12). There are two small windows to the south of the fireplace; one narrow light with splayed reveals and to its south another small window which has a concave reveal extending into the south wall of the room; the phasing of this area is not fully understood, and would benefit from further

*Fig.64: 19<sup>th</sup> century mullioned window to north*

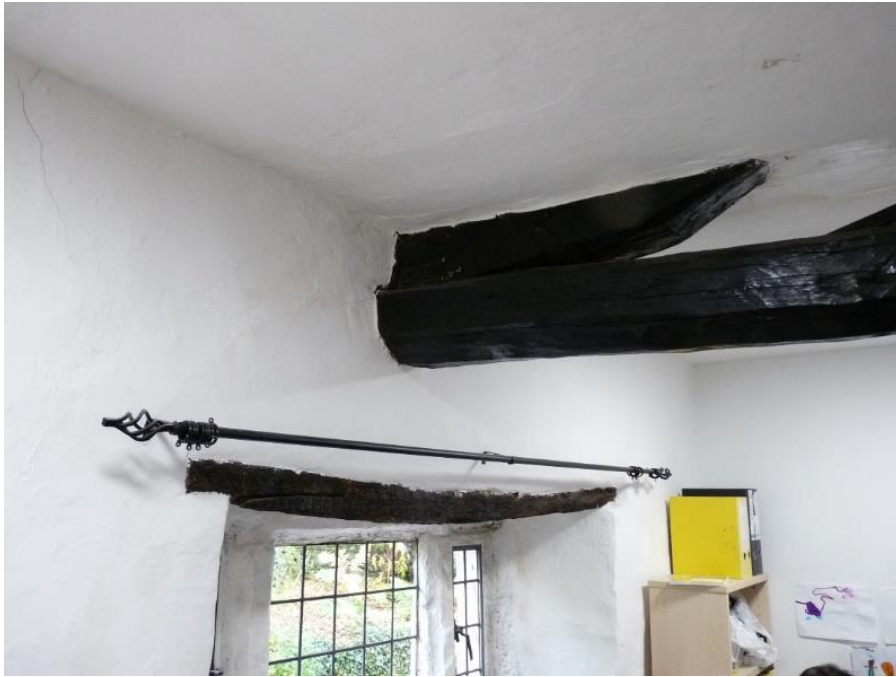
S10 – Staircase and office in north-east outrigger. The top floor in the outrigger is reached by a secondary staircase, a 19<sup>th</sup> century insertion. The plain staircase is pine, built against the west and north walls of the space. The room is lit by a mullioned window to the east, which has a missing central mullion (originally 4-light, now 3-light); the ogee-moulded mullions suggest a late 17<sup>th</sup> century date. The half-truss to the lean-to roof has a roughly chamfered tie-beam and principal, visible below the ceiling, with added reinforcement joinery. In a cupboard on the west wall, next to the staircase, there is a timber corbel with wrought iron bracket on its south face; this corbel is roughly 300mm below the ceiling, of unidentified purpose. It is of similar appearance to timber corbels in the rest of the building that carry sleeper beams, and may relate to an earlier (lower) roof structure. This room (or the room below – F10/11) may have been heated by a fireplace on the south wall, related to the external chimney visible on the north side of the stair tower in 1971; the stack was probably a 19<sup>th</sup> century insertion, removed after 1971.<sup>62</sup> The floor is carpeted and it is not known whether the floor structure is pre-19<sup>th</sup> century; this would need to be checked to clarify the phasing of the floor.

*Fig.65: window and east end of half-truss, from the north-west*

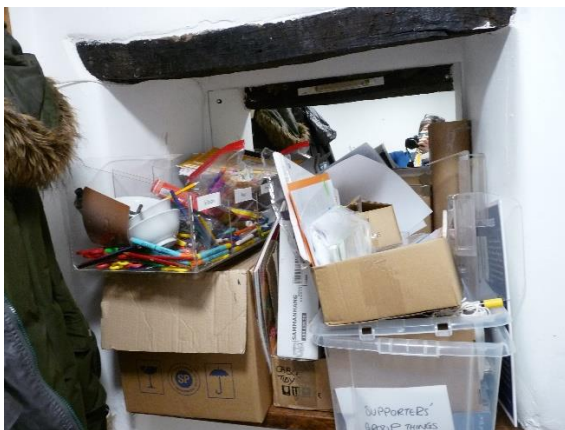
*Fig.66: blocked opening on north wall*

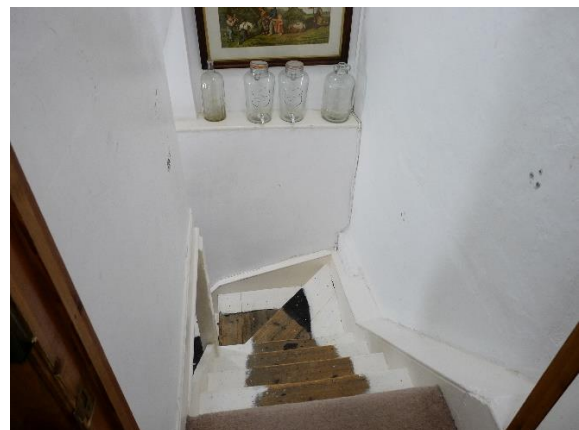
*Fig.67: 19<sup>th</sup> century staircase, from the east*

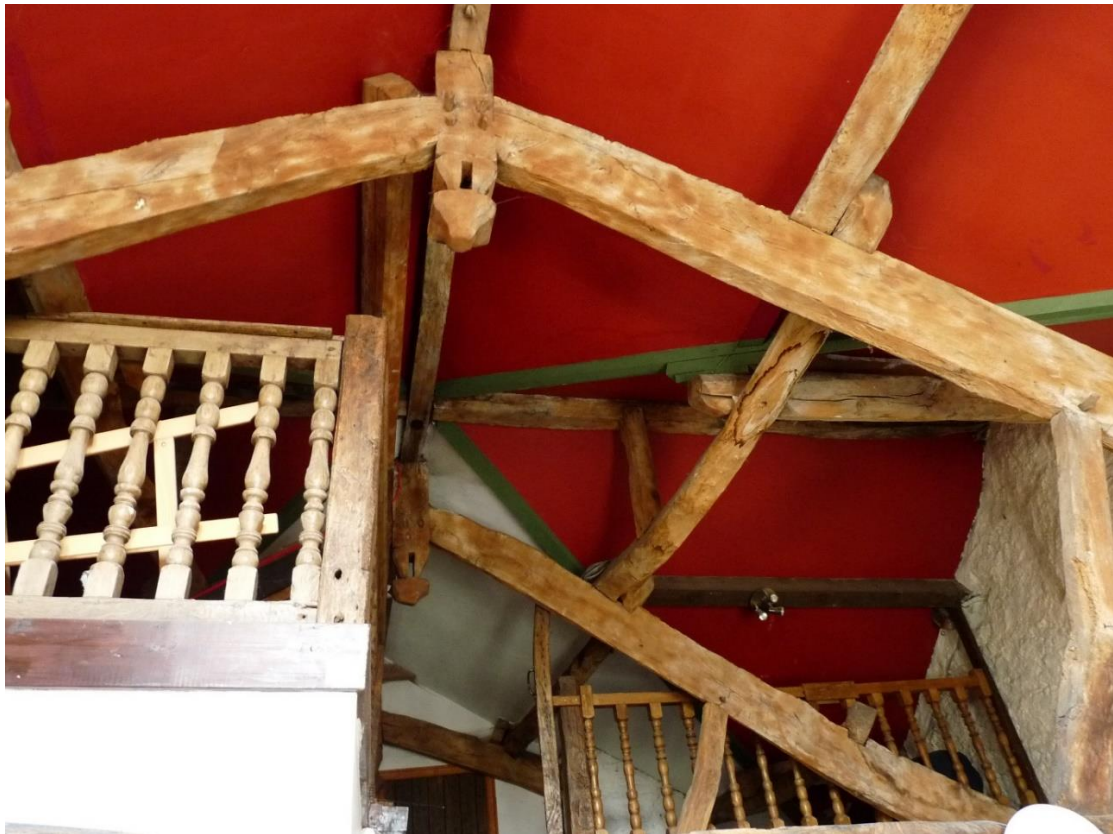
The 4-bay roof has king-block roof trusses typical of late 17<sup>th</sup> century roofs in North Craven;<sup>63</sup> the king blocks have ogee pendants and mortices for missing ridge braces. The trusses and purlins appear to be of one phase in the three west bays, with incised assembly numbers on the east faces of each truss (numbered from west to east); the ridges have been replaced. The three west bays of the roof have been under-drawn, concealing rafters. The northern bay has been re-roofed with pine rafters and sarking felt; one of the north purlins is a re-used floor beam (Fig.69).

*Fig.68: king-block roof trusses in the north wing, from the west*

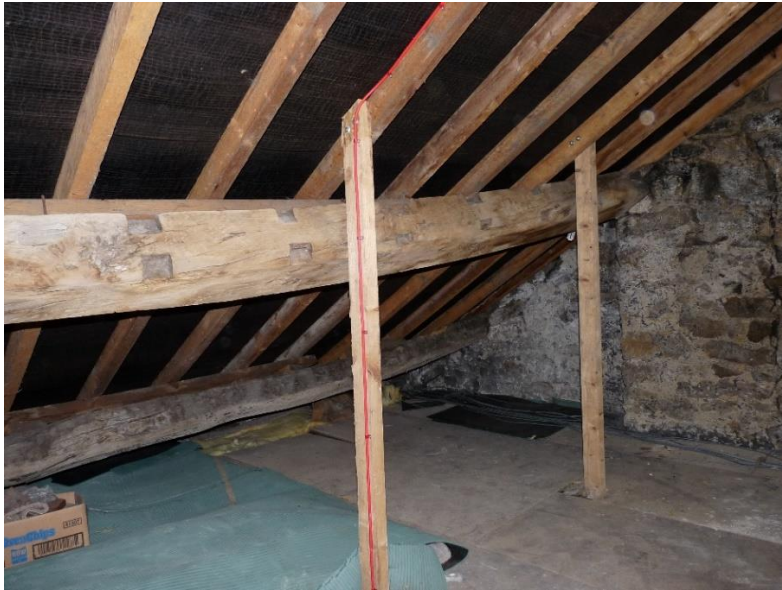
*Fig.69: north bay of north wing roof, with re-used floor beam for a purlin*

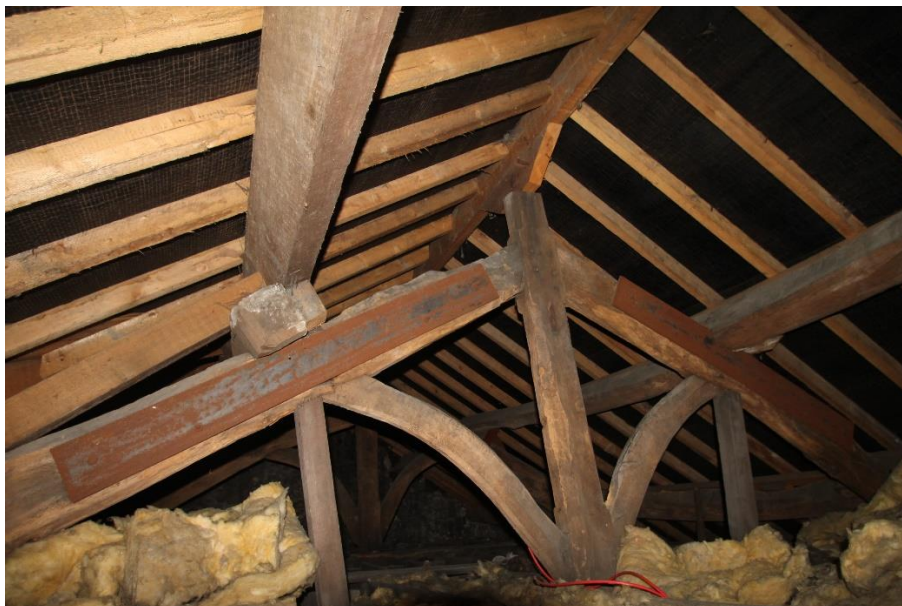
*Hall Range Roof* – Two hatches give access into the roof over the hall range. This 3-bay roof appears to be of broadly the same phase as the north wing roof, but with a differing late 17<sup>th</sup> century truss type. The purlins from the hall range roof are pegged onto the purlins and members of the north and south range roofs. The roof structure consists of two king-post trusses with two pairs of curved struts, with added vertical struts. There are two tiers of through purlins, partly replaced in pine. The roof has been re-roofed with pine ridges, rafters and sarking felt, in the late 20<sup>th</sup> century. Steel plates have been fixed to the two trusses, for reinforcement.

*Fig. 70: hall range roof from the north (Mark Fletcher, Matrix Archaeology)*

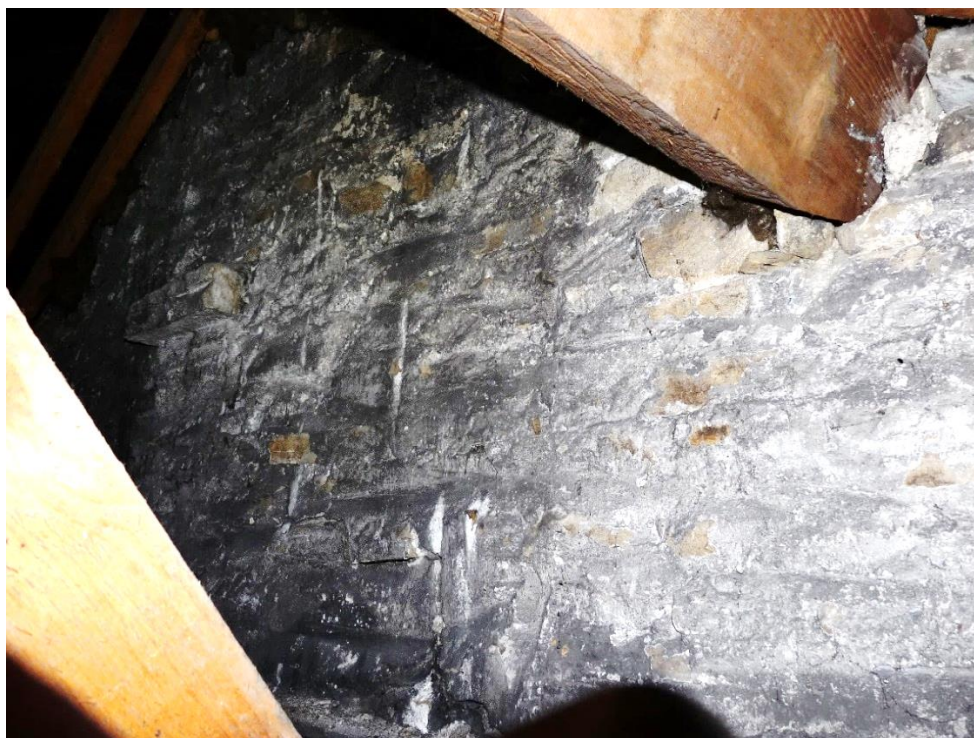
On the east side of the roof space, the west face of the stair tower is visible, below a section of connecting roof of pine construction; the wall is fair-faced rubblestone with some projecting features that merit further investigation (Fig.71). This is a potential location for historic staircase access into the tower. Full access was not possible to this area.

*Fig.71: west face of tower from within hall range roof, from the south-west*

The tower remains a puzzling part of The Folly; leaving this untouched maintains the fabric as it is and building's mystery, but may hinder future maintenance. Access into the upper stages of the tower is currently very difficult and it is uncertain how the tower was historically accessed, if at all. It is recommended that a range of options are explored, through drawings, before determining whether there is scope for improving access. New access is likely to entail a major change to the character and internal appearance of the tower, and possibly to its structure, whether the access is for occasional maintenance or public access.

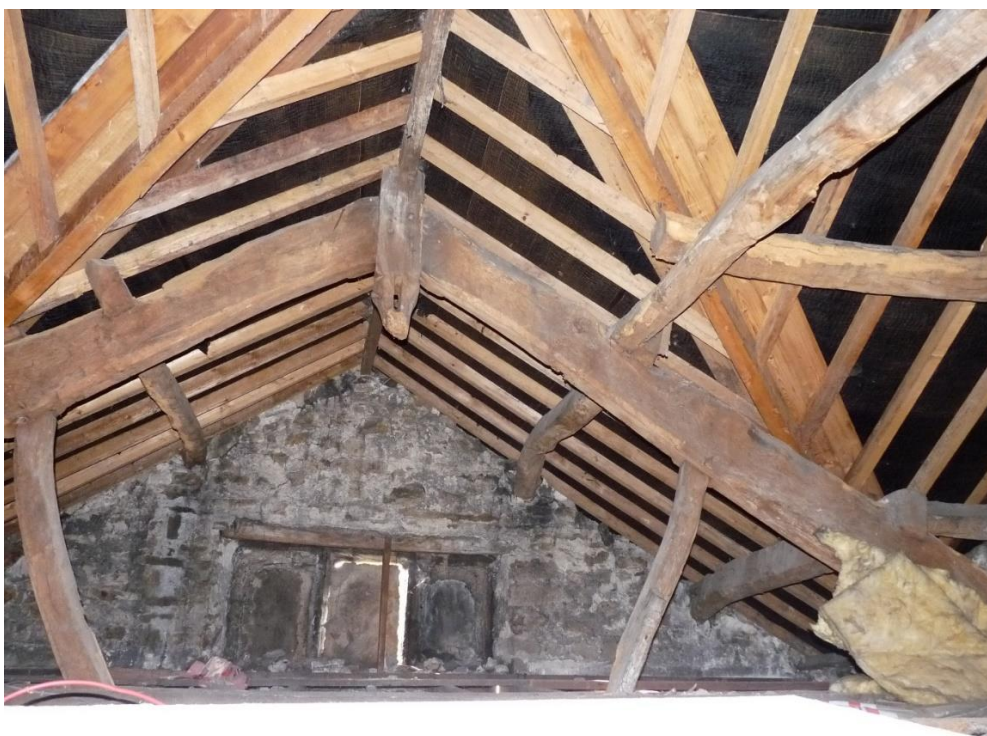
*South Wing Roof* – the structure of the 3-bay roof over the south wing consists of two king-block roof trusses with rafters, ridge and two tiers of through purlins. The king-blocks are of a differing design to the those in the north wing roof, and more eroded, with a hollow-moulded pendant instead of ogee pendant. Braces to the ridge are missing, probably removed when the ridge was replaced.

*Fig.72: south wing roof from the east*

The purlins of the hall range roof appear to be pegged onto the south wing purlins. The south wing roof has been re-roofed with pine rafters, replacement valley timbers and sarking felt, as part of the late 20<sup>th</sup> century repairs. The 3-light mullioned windows to the west gable-end are blocked with stone slabs (Fig.72), and walls are fair-faced rubblestone.

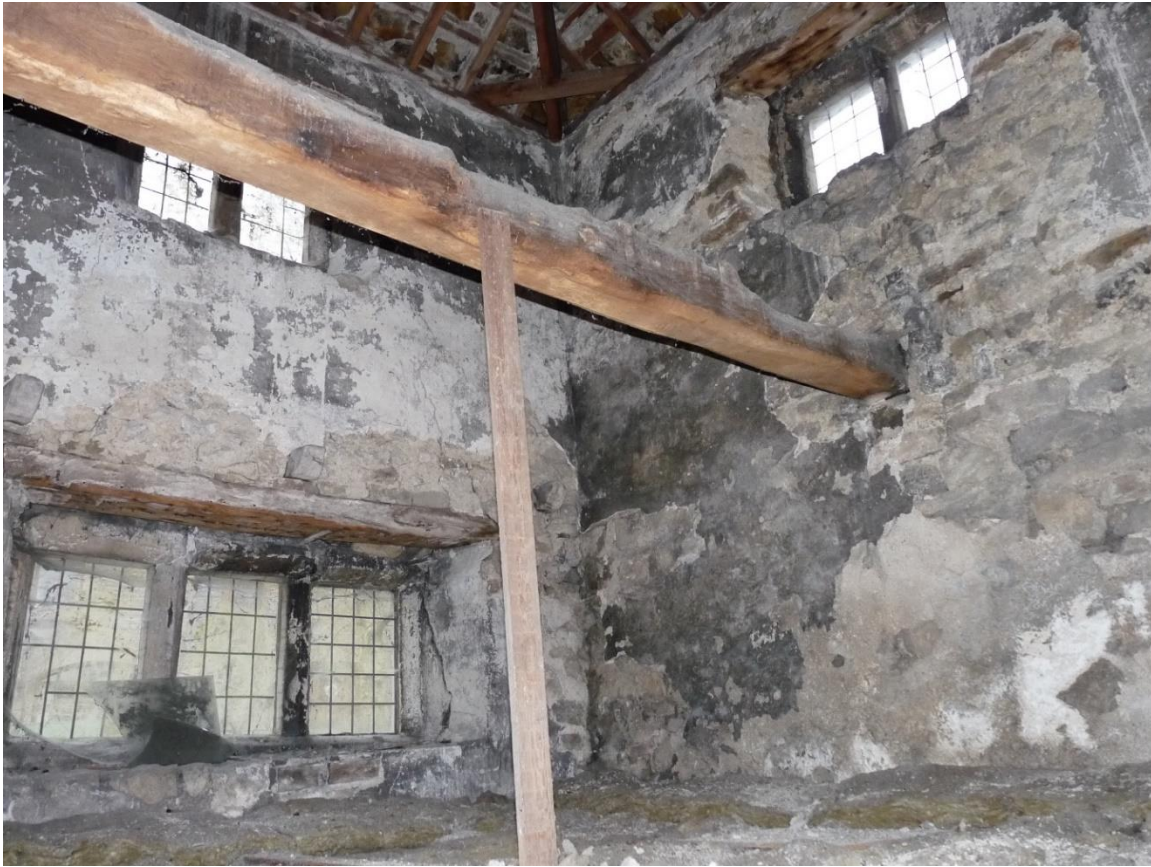
The tower has a 3-light window to the east face, approximately 300mm above the inserted ceiling; this has an oak lintel with nails for missing laths, plastered splayed reveals but no window boards. The upper part of the tower has a 2-light mullioned window to the north, south and east walls and a 3-light window to the west wall with the middle light blocked with rubble fill; these openings have similar oak lintels and splayed plastered reveals.

wall is less clear, as plaster is missing from the level of the timber corbels. On the west wall there is a horizontal timber of unknown purpose fixed to the wall, on the north side of the window.

*Fig.73: inside the tower, from the north-west*

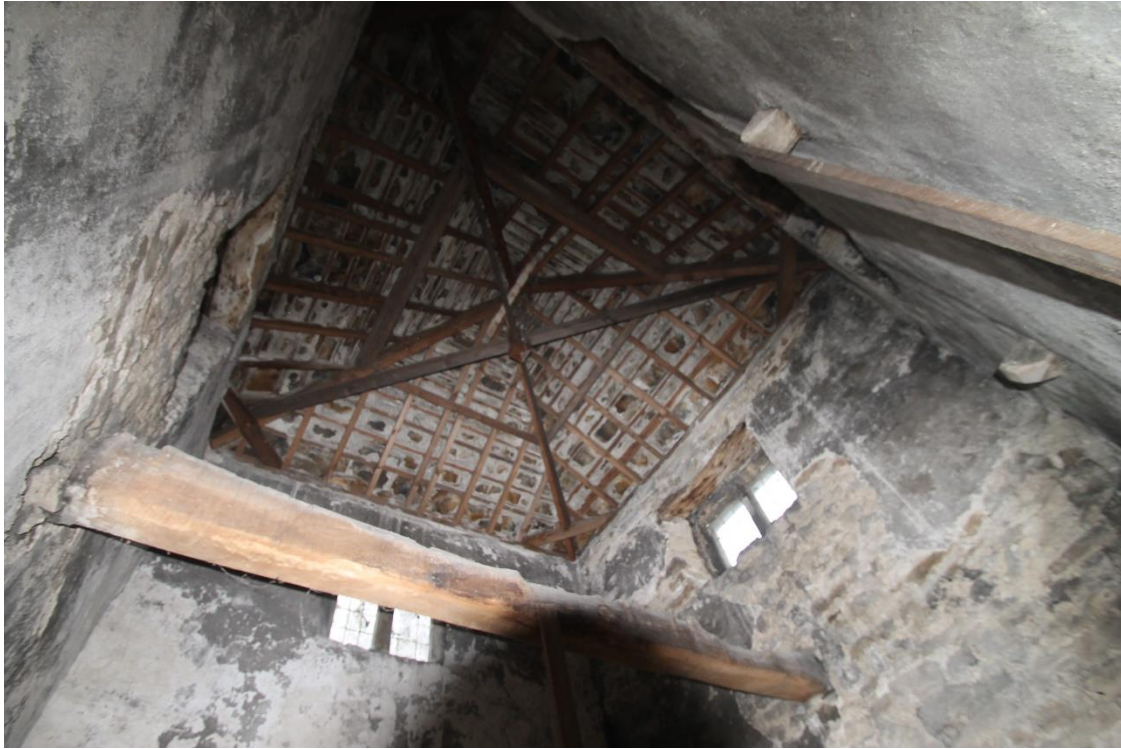
*Fig.74: tower roof and walls (Mark Fletcher, Matrix Archaeology)*

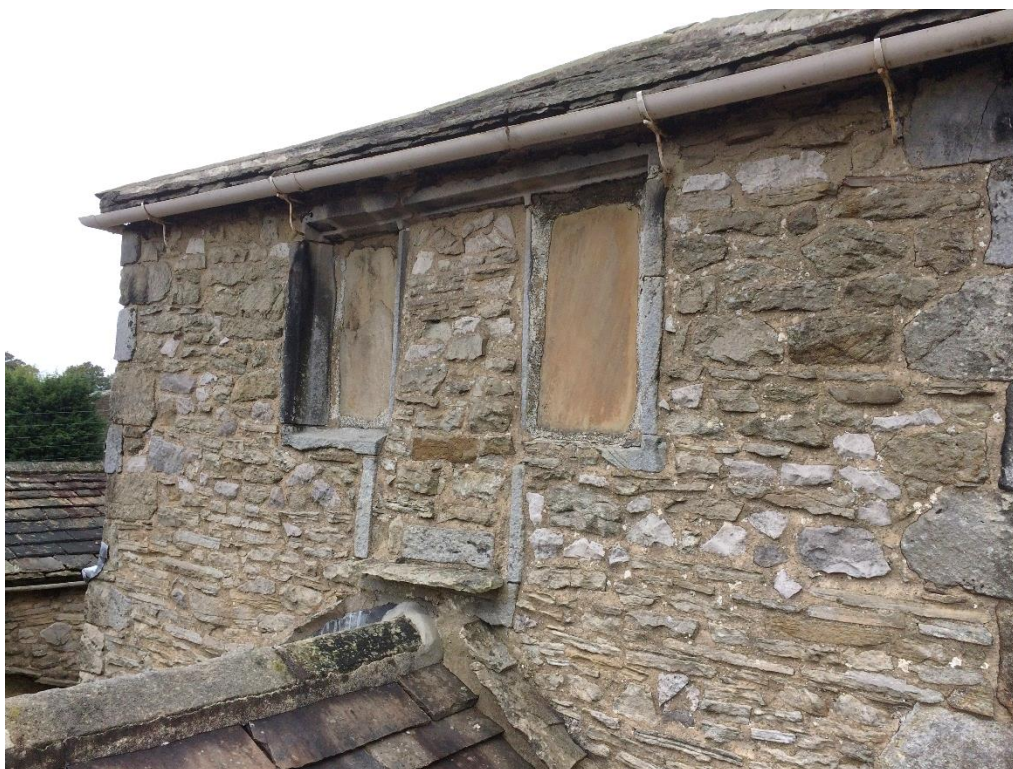
*Fig.75: west face of the tower, from the roof, with central 'doorway' to the blocked window  
(photo: Lynn Northrop, Overton Architects)*

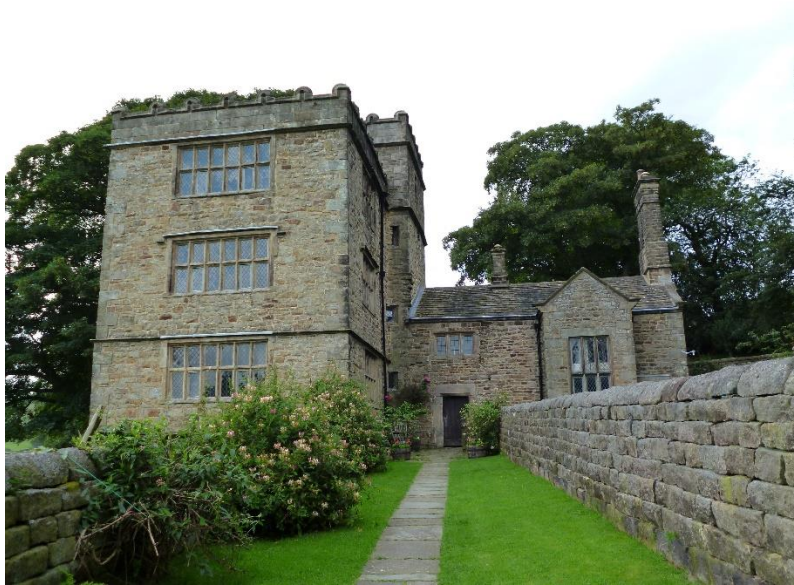
Prospect towers were built by the nobility from the 16<sup>th</sup> century, on or at houses built for the nobility or gentry. This type of structure was partly derived from the hunting towers or lodges built in deer parks, such as North Lees near Hathersage or at Chatsworth, both in Derbyshire or Turton Tower in Lancashire. Roof-top rooms on country houses used for banqueting, built on the lead flats (roofs) of Elizabethan prodigy houses such as Longleat or Woolaton, were also part of the Elizabethan taste for small rooms with a panoramic view. The idea filtered further down the social scale in the 17<sup>th</sup> century; at minor gentry houses, prospect towers occur on Bank Hall, Bretherton, Lancashire where the brick tower was added in the mid 17<sup>th</sup> century.<sup>66</sup> At Lawkland Hall near Settle, the stone stair tower is similar to The Folly's in materials, form and position with a pyramidal roof and 2-light mullioned windows to the upper stage, although it contains a stone staircase; the front of this larger house is dated 1679, although the roof of the tower is dated 1758.<sup>67</sup>

*Fig.78: North Lees, Derbyshire, a late 16<sup>th</sup> century hunting lodge*
