# **The Folly, Settle, North Yorkshire**

## **Statement of Heritage Significance & Scope for Change**

The Folly, Victoria Street, Settle, BD24 9EY

Statement of Heritage Significance & Scope for Change

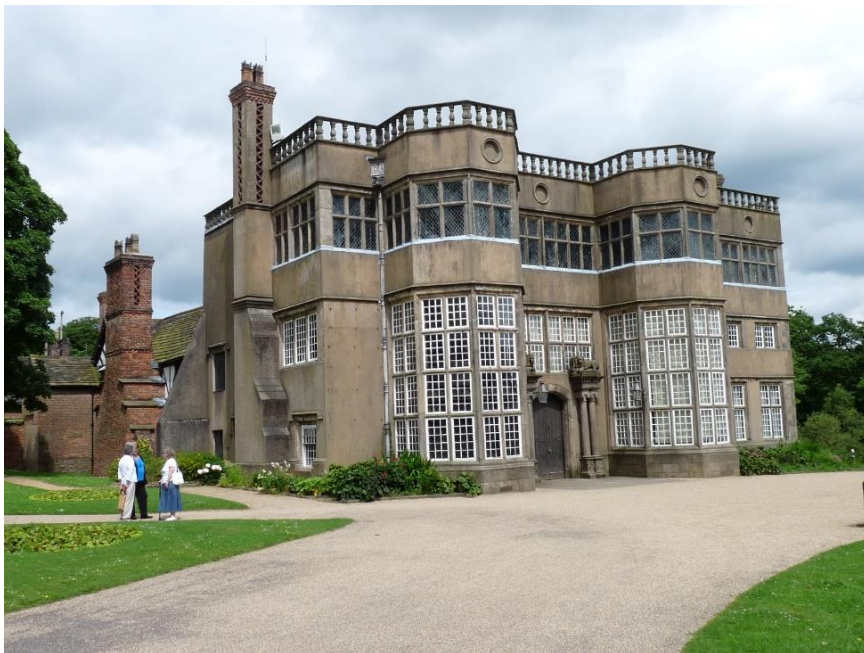
The inclusion of Renaissance features such as the Serlian arched transom windows to the front elevation has been discussed by other architectural historians; Peter Leach highlights the use of continental pattern books as the source for these windows and the hall doorway.<sup>69</sup> In the 16<sup>th</sup> and 17<sup>th</sup> century a taste for architectural motifs derived from continental Europe spread across Britain via printed books on architecture owned by the nobility and gentry; books by Vredeman de Vries (1565) or Sebastian Serlio (1537-51) contained elevations and plans, and also drawings for details such as strapwork (used in decorative stone, plasterwork and joinery), window glazing and chimneypieces. From the 16<sup>th</sup> century, Renaissance features became fashionable in high status aristocratic houses, before filtering further down the social scale to minor gentry houses during the 17<sup>th</sup> century; Astley Hall is a typical example with classical features on the same elevation as mullioned and transomed windows.

*Fig.79: Astley Hall. Chorley, a timber-framed house, re-fronted in the early 17<sup>th</sup> century*
