# THE FOLLY, SETTLE

## CONDITION SURVEY

## **The Folly, Settle – Condition Survey Notes**

Inspection undertaken on Thursday 3<sup>rd</sup> June 2021 by Sheila Overton. The weather was overcast and dry. The previous inspection was undertaken by Sheila & Mike Overton on 11<sup>th</sup> October 2016.

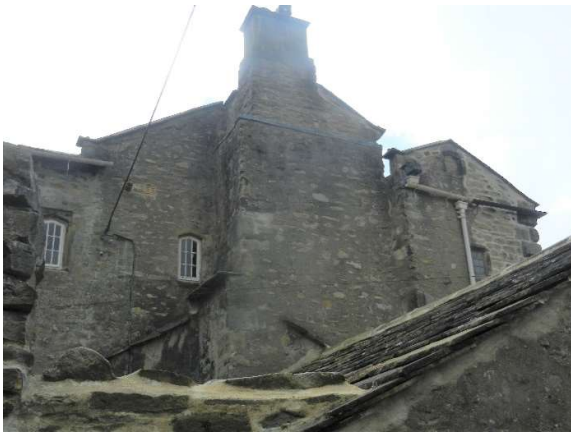
photo 2 – north elevation

- 3.03 **North Elevation** – The walls are random sandstone which has been covered with a cementitious mortar. There is a substantial central chimney breast and a single storey extension (photo 3). Stone erosion is evident in the exposed stonework (photo 16). The north-eastern corner of this elevation has been repointed in hot lime and the difference is striking.

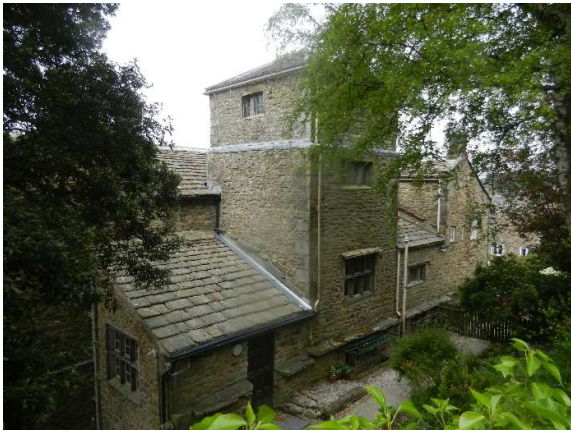
photo 3 – west elevation

- 3.04 **West Elevation** - The rear elevation is composed of several separate elements in an informal arrangement including a 4-storey tower (photo 3). The ground rises significantly to the back of the building with entrances at first floor level. The walls are random coursed sandstone with gritstone quoins. The windows and doors do not have stone surrounds. The stonework has cementitious pointing.
